## Waikato River Erosion Study

### Volume 1

**Mighty River Power**

42089850 - Rev A

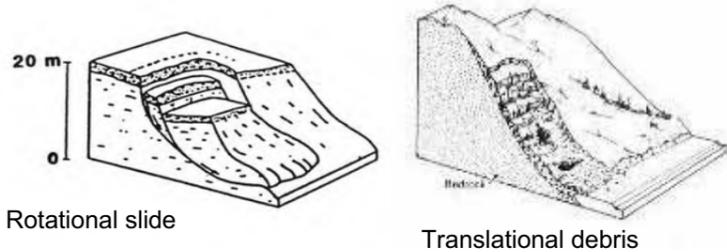
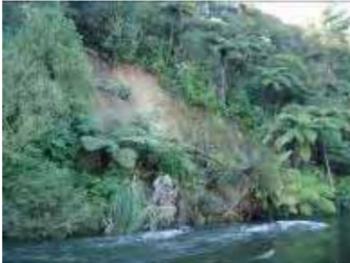
<p>Rotational slide      Translational debris</p>

Failure Type (from Varnes, 1975)	Characteristics	Example	Waikato River Example
Slide	<p>Down slope movement of soil and/or rock mass occurring predominantly on surfaces of rupture or thin zones of shear strain.</p> <ul style="list-style-type: none"> <li>Volume of displaced material enlarges from an area of local failure.</li> <li>Often first signs of movement are cracks in original ground surface along which the main slide scarp will form.</li> <li>Modes of sliding include rotational and translational.</li> </ul>

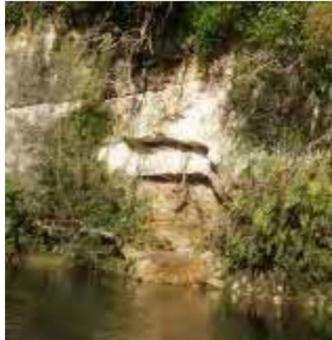
Fall	<p>Starts with detachment of soil and/or rock from a steep slope along a surface with little or no shear displacement.</p> <ul style="list-style-type: none"> <li>Material descends mainly through the air by falling.</li> <li>Movement is rapid.</li> <li>Except when mass has been undercut, falling will be preceded by small sliding or toppling movements that separate the displaced material from the undisturbed mass.</li> <li>Undercutting by waves or eroding river bank can initiate.</li> </ul>

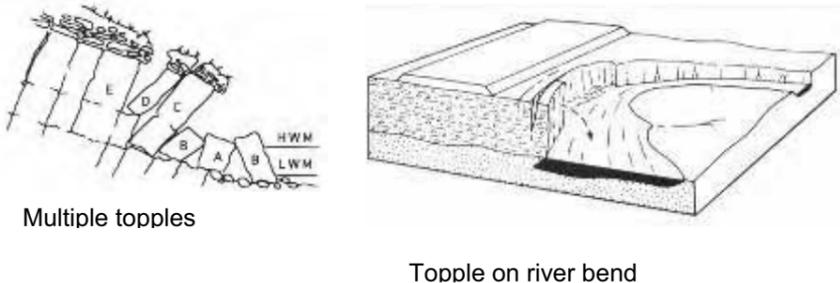
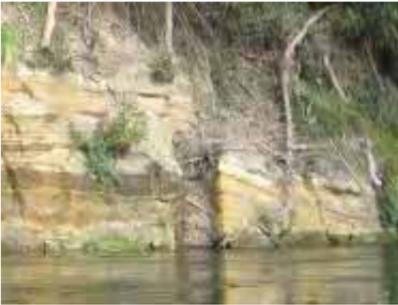
<p>Multiple topples      Topple on river bend</p>

Topple	<p>The forward rotation out of the slope of a mass of soil and/or rock about a point or axis below the centre of gravity of the displaced mass. May be very slow or rapid.</p> <ul style="list-style-type: none"> <li>May be driven by gravity exerted by material upslope of the displaced mass.</li> <li>Topples may lead to falls or slides depending on the geometry of the moving mass and surface of separation.</li> </ul>
