# The Weather Bomb 21 June 2002

## Final Technical Report

Prepared by:  
Adam Munro

For:  
Environment Waikato  
PO Box 4010  
HAMILTON EAST

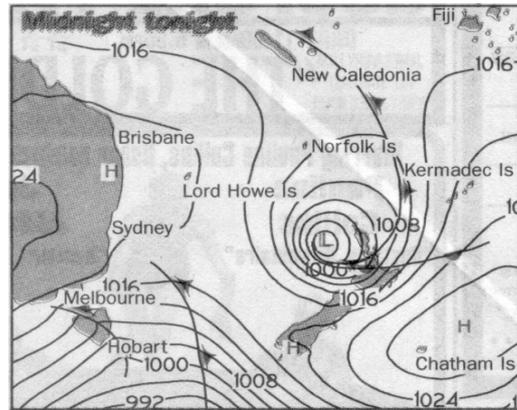
*A weather bomb is simply defined as a low pressure system which rapidly deepens causing barometric pressure to drop by at least 25 hPa in a 24 hr period (see above weather map).*

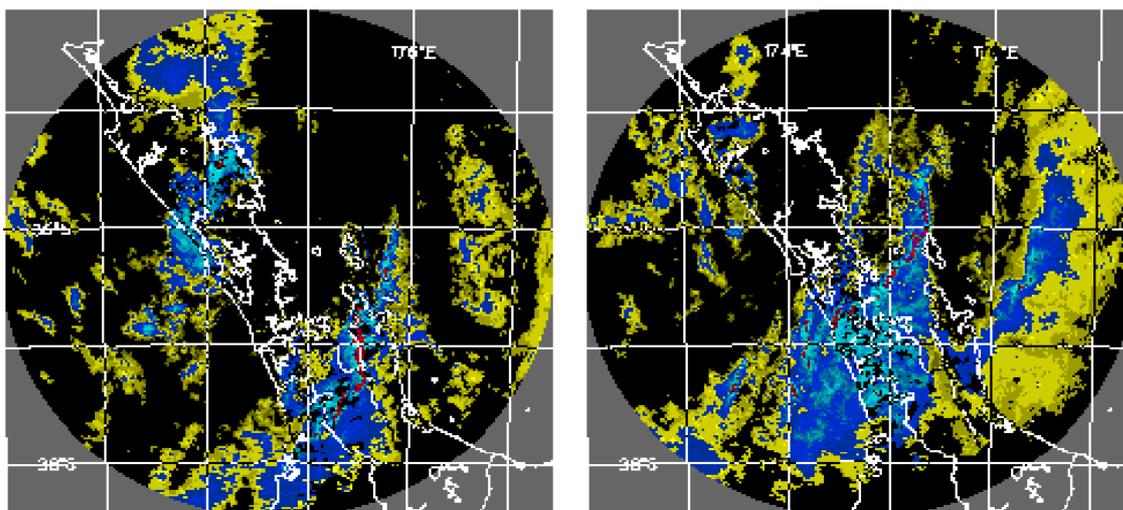
**Figure 1: Auckland Weather Radar images showing heavy rainfall bands during the evening of Thursday 20 June.**

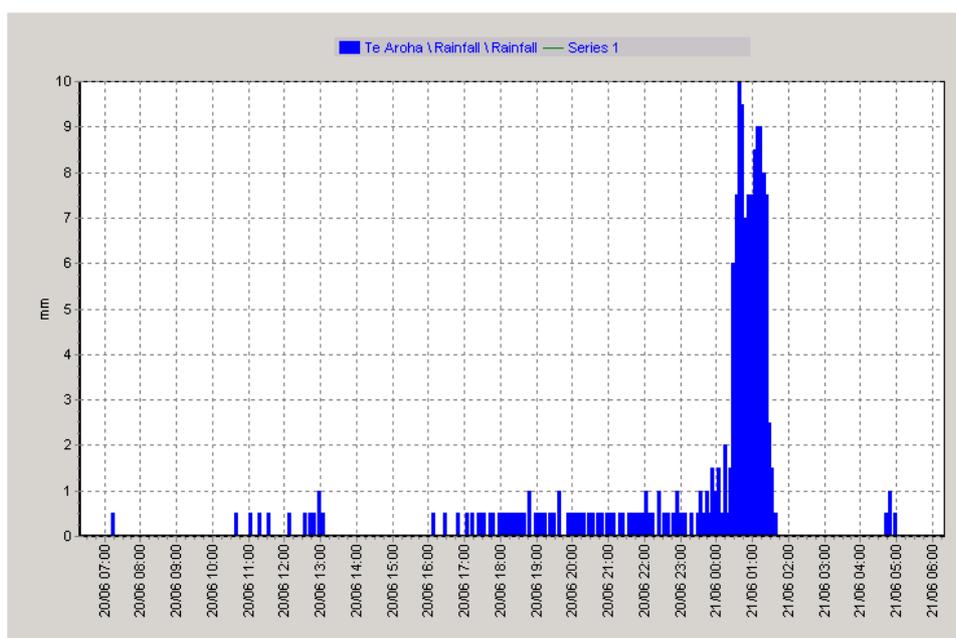
Figure 2: Plot of rainfall intensities recorded at Te Aroha.

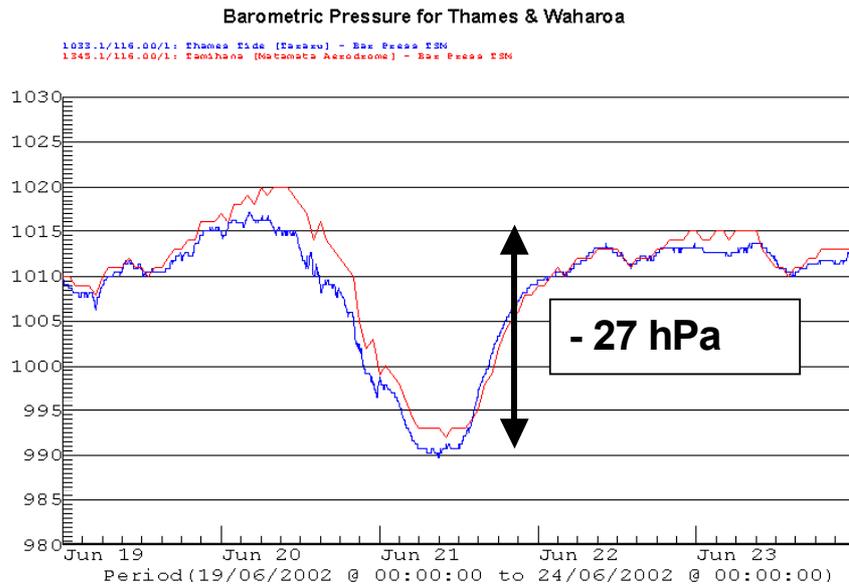
As the storm progressed southeastwards over New Zealand, the centre of the “Bomb” deepened to about 980 hPa. Immediately preceding the storm, BP hovered between 1015 and 1020 hPa and after the storm had passed through, BP quickly increased to 1012 hPa. The lowest (unconfirmed) barometric pressure recorded in the region for the event was 984 hPa at Tapu (between 3am and 6am, 21 June). Figure 2 shows the “dipping effect” on BP as the storm passed over Thames and Waharoa.

**Figure 3: Barometric Pressure readings from Thames and Waharoa.**

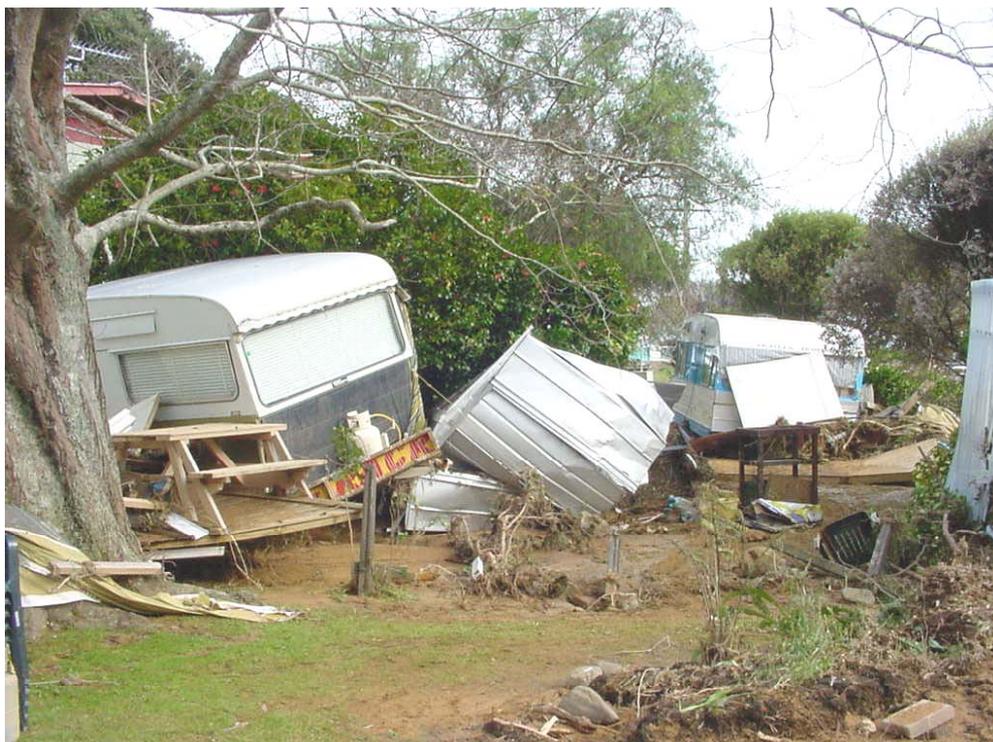
While the major river systems across the Region generally coped very well with the deluge, it was the smaller streams north of Thames (associated with short, steep catchments) that bore most of the storm's sting. The Tararu, Te Puru, Tapu, Waiomu, and Waikawau Rivers (and many streams in-between) all burst their banks sending tonnes of mud and debris through homes and properties. To put it in perspective, peak flows estimated for several of these streams exceeded the annual mean flow for the Waikato River through Hamilton (by up to 80 cumecs). Severe infilling occurred as a result of heavy bedload movement and slipping. Lateral erosion was evident throughout most catchments and the flood struck with enough force to move caravans, garages, boats and cars (see Figure 4 below).

**Figure 4: The Waiomu Motor Camp, which was devastated by the flood.**

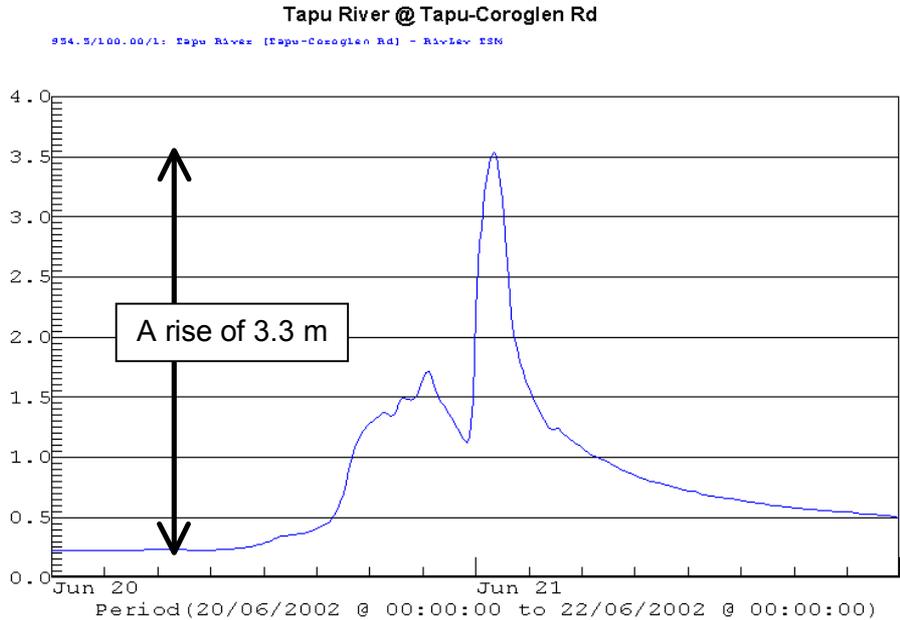
- Tapu River: similar to 1985 event, 20-30 year event (see hydrograph below)

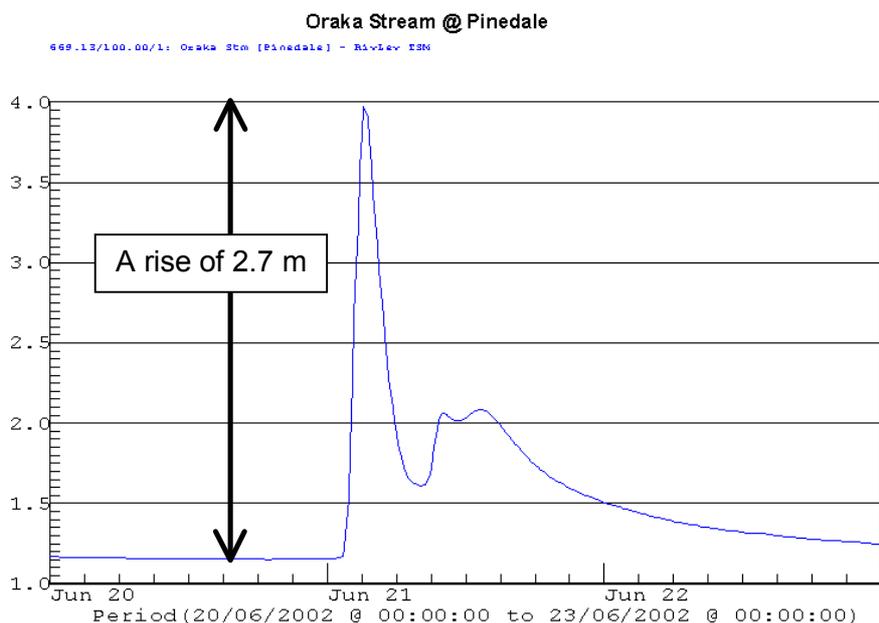
- Waiomu: 20 - 30 year event (similar to 1985)
- Te Mata: 20 - 30 year event
- Te Puru: similar to 1985 event (20 - 30 year event)
- Tararu: similar to the January 2002 event (100 year event)
- Thames: 100 year event (Karaka Stream)
- Tairua River: 5 year event
- Kauaeranga River: 5 year event
- Waitoa River: 50 – 100 year event
- Pokaiwhenua River: 100 year event
- Oraka River: 100 year event (see hydrograph below)

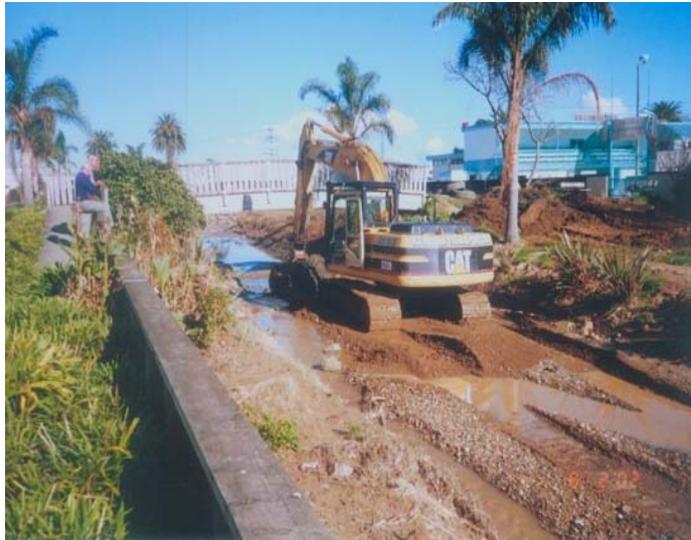
**Figure 5: Clean up works in progress on the Hape Stream in Thames.**

Channel re-instatement commenced on June 24. Works included the removal of vegetation at debris trap sites, stabilisation of bank erosion through the placement of rock from within the channel.

Works were completed during the first week following the event. No modifications to the original scheme standard took place.

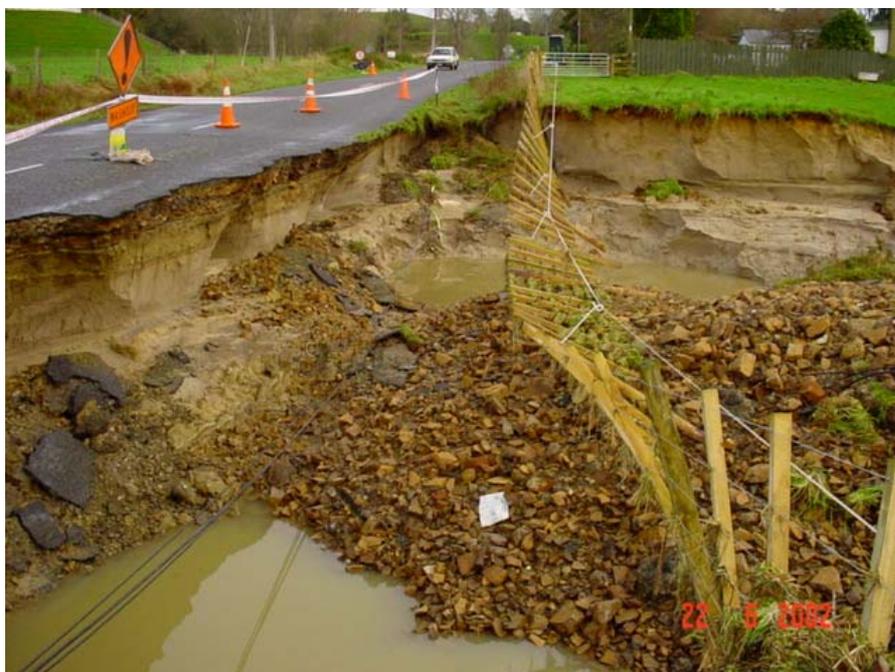
- Police requested an emergency declaration on the evening of Thursday June 20.
- Power losses had a major impact on water and sewage systems.
- There was confusion as to which power company had responsibilities in the district.
- A Civil Defence Emergency was declared at 8am with danger to residents, health risks and the full extent of damage unknown (due to loss of telemetry).
- 11 houses inundated (Putaruru/Tirau).
- 40 homes needing new carpet (from sewage contamination).
- Scouring of roads, some closed by slips (Figure 6).
- 30 vehicles damaged or written off.
- Woolworths Supermarket flooded in Putaruru.
- Approach to the Horahora Bridge washed away.
- Many of the emergency services in the district have to report to headquarters outside the region (e.g. fire service, health, and police). This can lead to confusion.
- Extensive stream bank erosion (see below)

## Figure 6: Stream bank erosion in the South Waikato District.

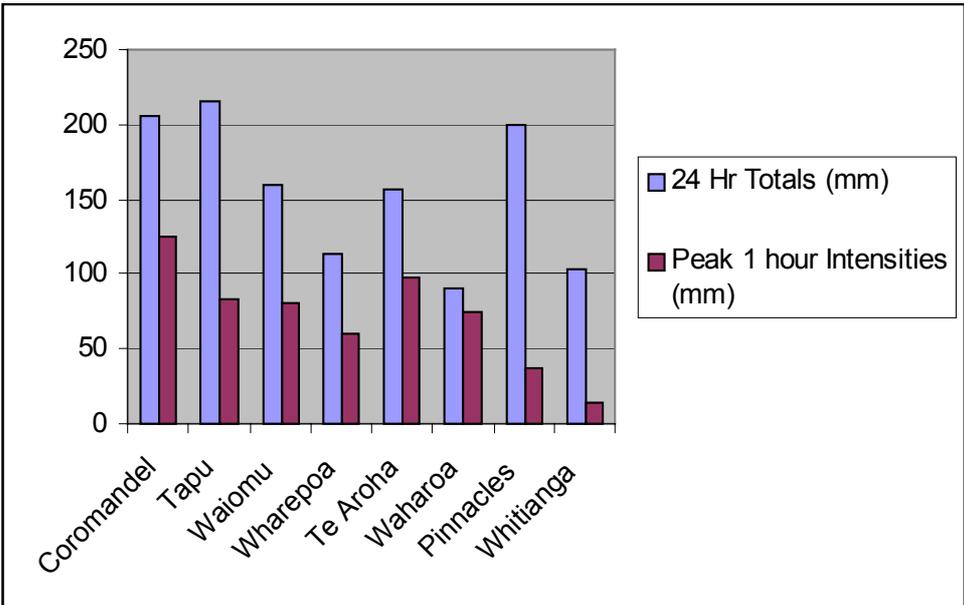
**Figure 1: Plot showing rainfall totals and peak one-hour intensities across the Thames Valley area.**
