Degradation
of the
Waikato River

Karapiro
to Ngaruawahia

Review of
Existing Knowledge
& Recommendations
for Future Work

Environment Waikato
P.O. Box 4010, Hamilton East.
August 2003

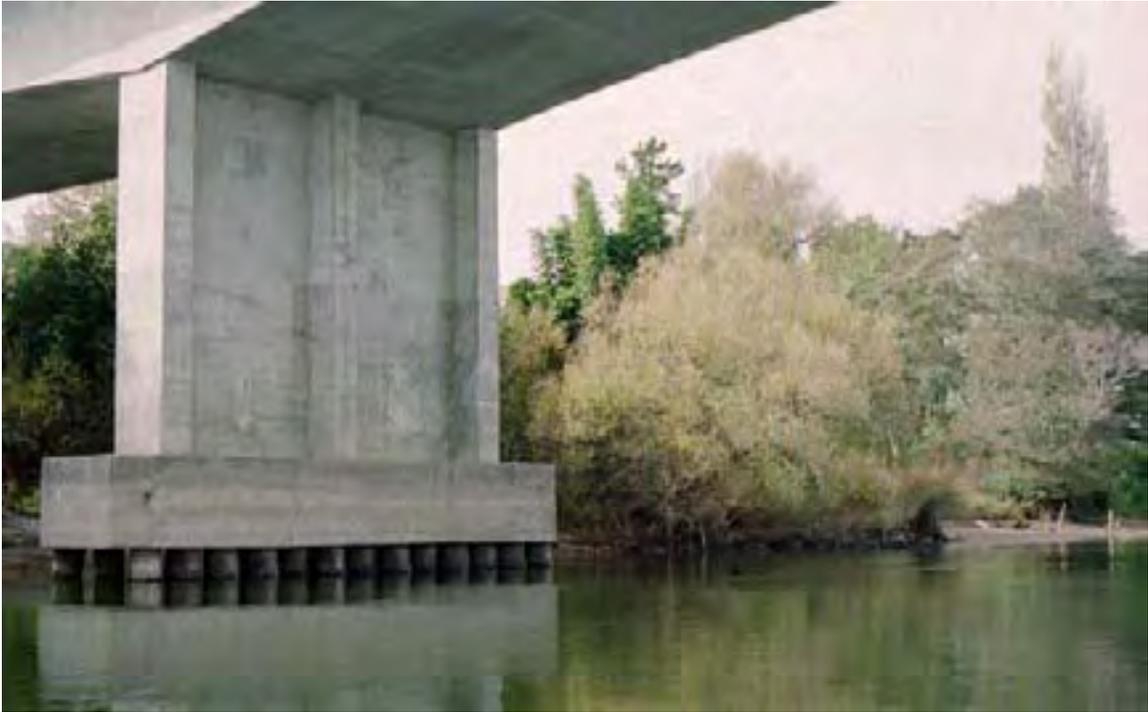
Figure 1 Pukete Bridge showing piles exposed below the pier cap.

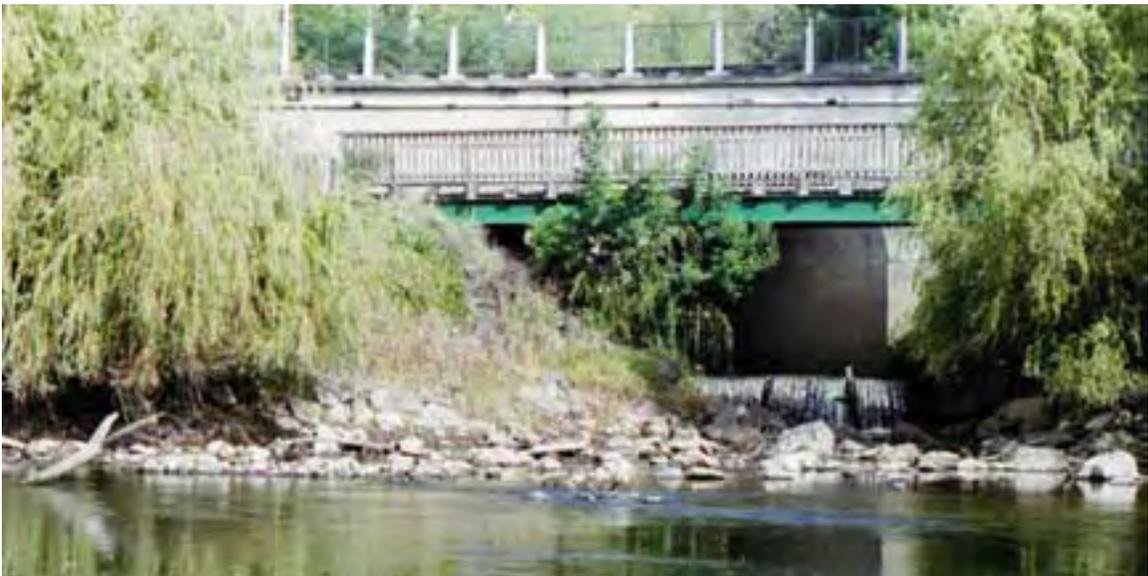
Fig. 2 shows the Waitawhiriwhiri Stream confluence is hanging on the left bank of the Waikato. It has a weir and dumped rock for protection against down cutting.

Figure 2 Waitawhiriwhiri Stream confluence.

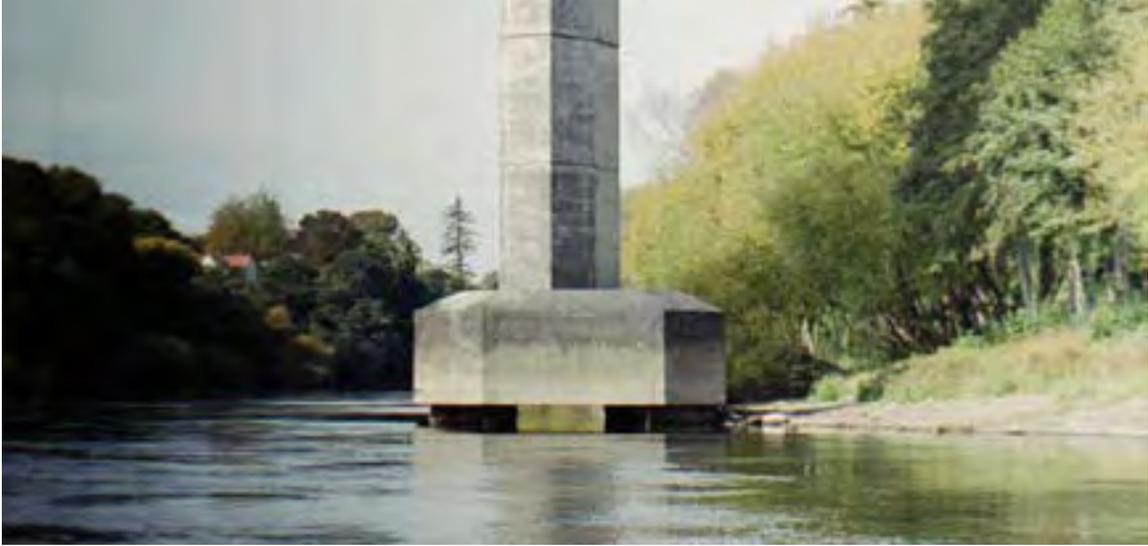
Fig. 3 shows the Boundary Road Bridge pier.

Figure 3 Boundary Road Bridge looking upstream

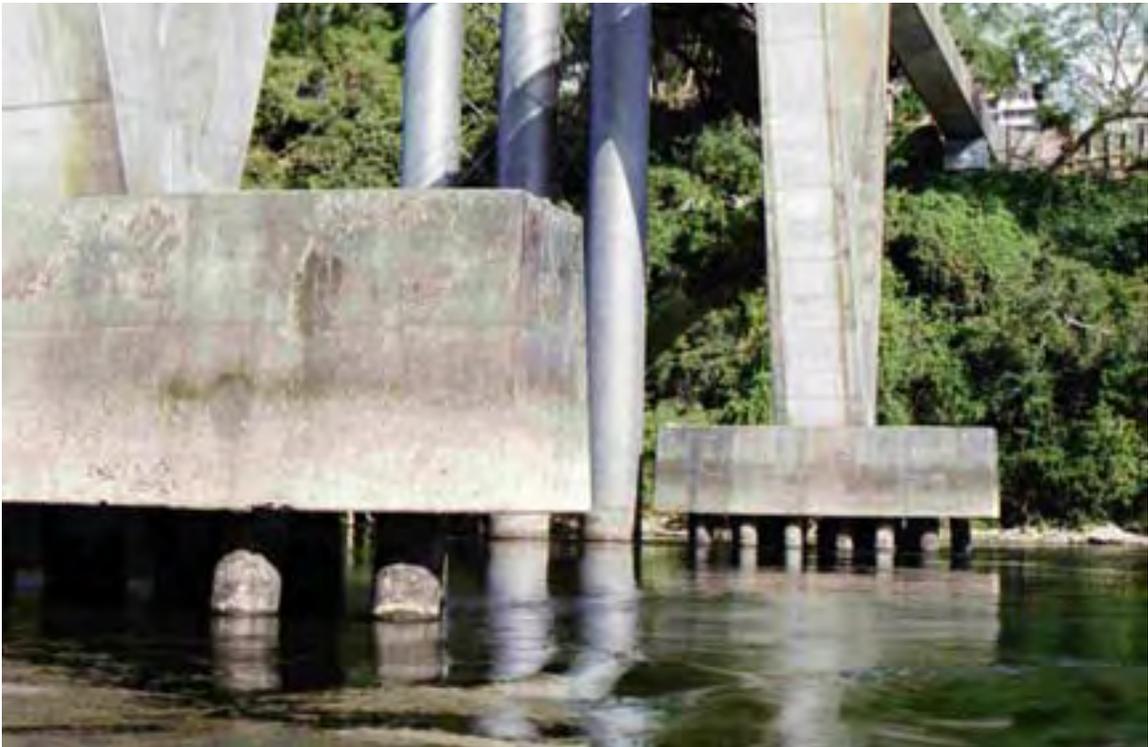
Exposed piles below Claudelands Road bridge piers are shown in Fig. 4.

Figure 4 Claudelands Road and Rail Bridges

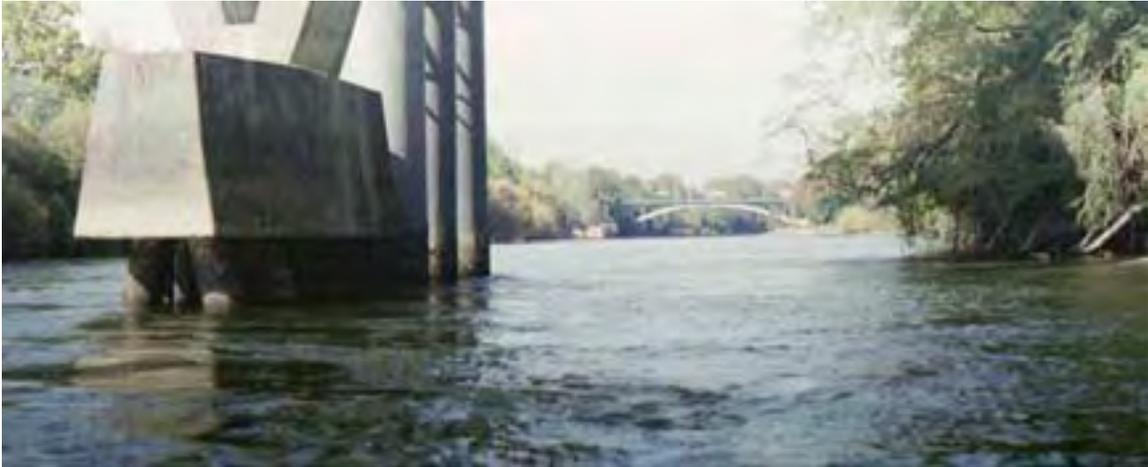
Figure 5 Piers of Claudelands Bridges, looking upstream to Victoria St Bridge

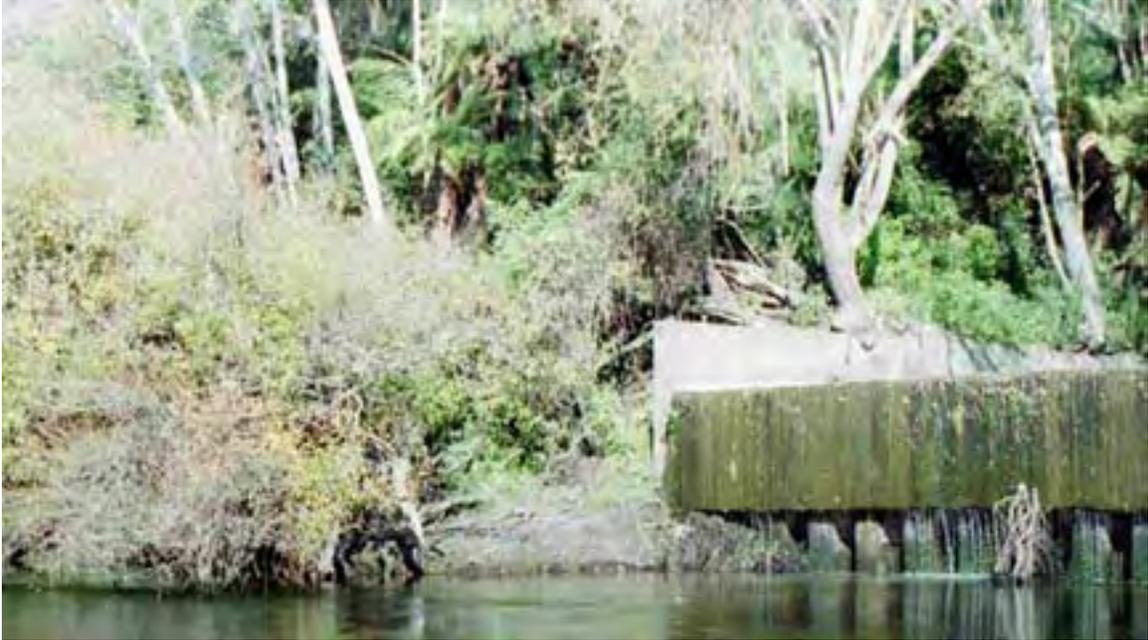
Hospital Drain entrance is hanging as shown in Fig. 6.

Figure 6 Hospital Drain Confluence

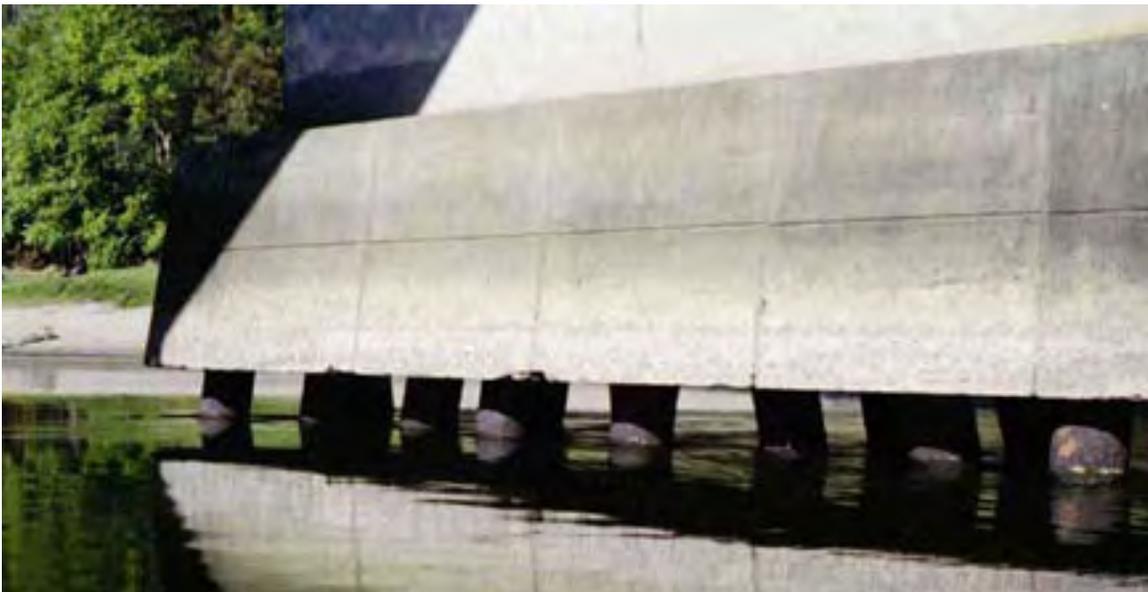
Cobham Bridge piles are exposed beneath the pier as shown in Fig. 7.

Figure 7 Cobham Bridge Pier

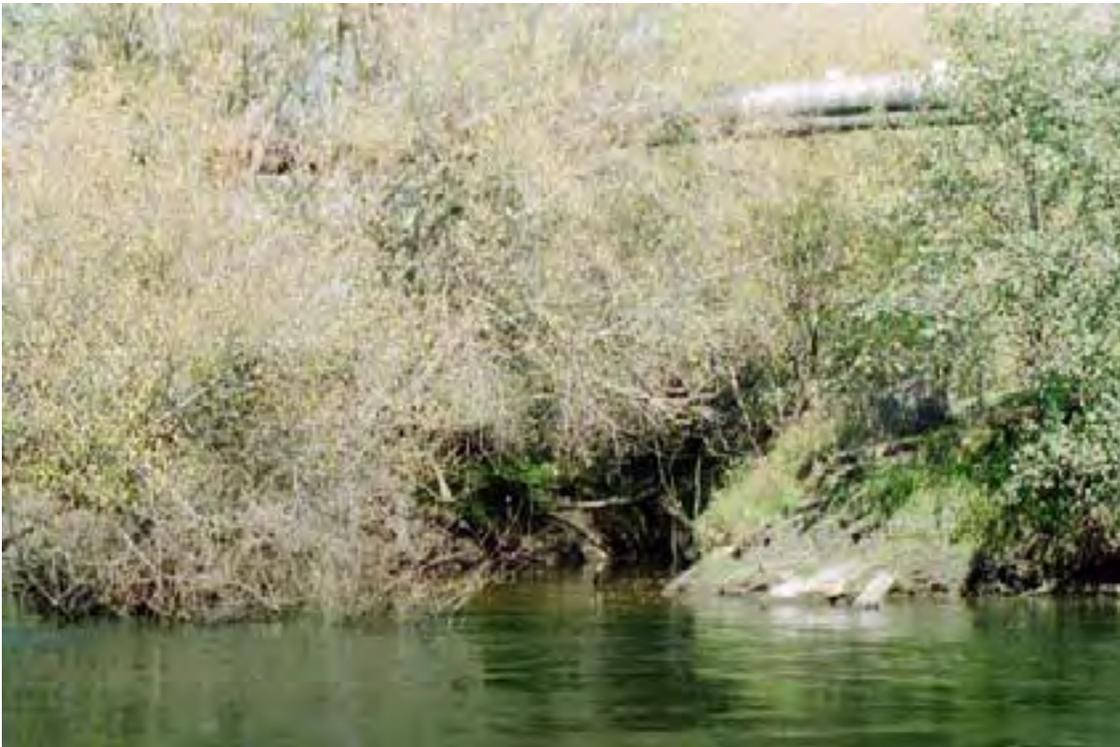
Figure 8 Mangakotukutuku Stream Confluence

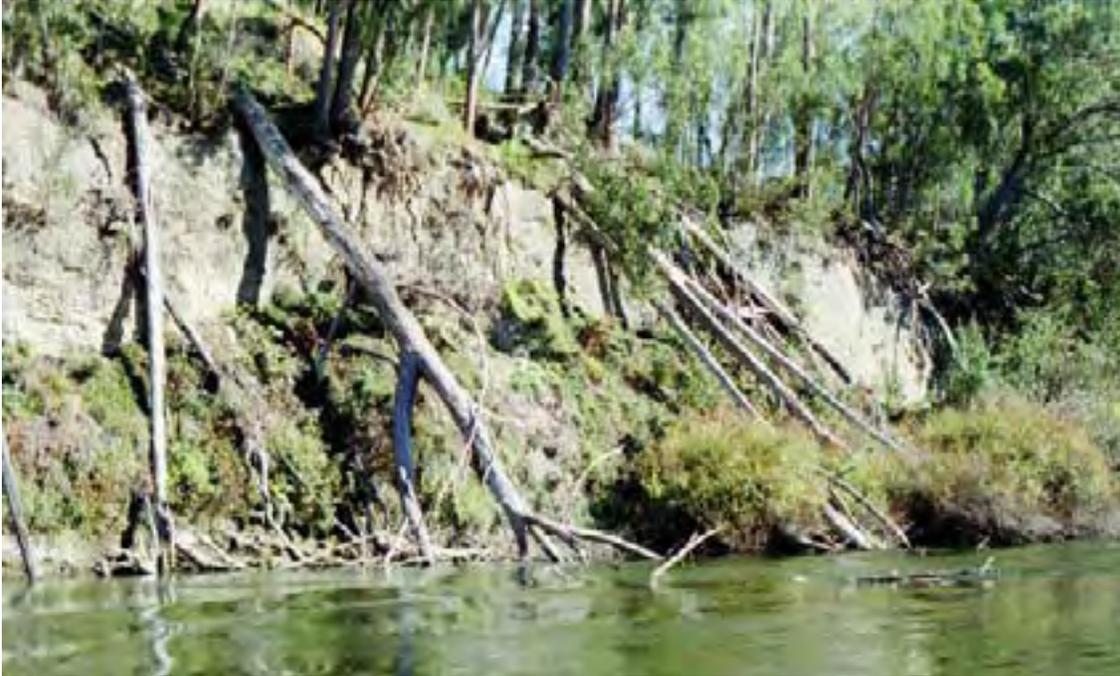
1 km downstream of the Narrows Bridge the bank is collapsing into the river as shown in Fig. 9.

Figure 9 Bank collapse downstream of the Narrows Bridge

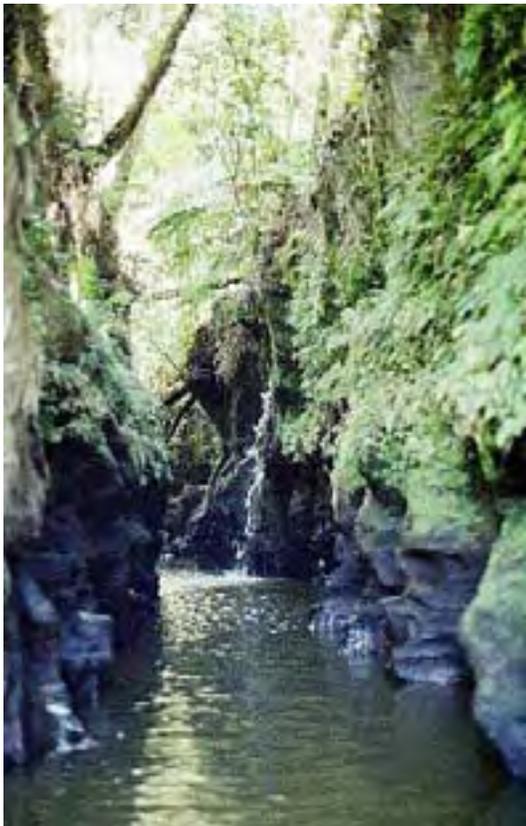
Mystery Creek joins the Waikato 2 km upstream of the Narrows Bridge, the creek has steep banks (Fig. 10). Two Totara trees help protect the confluence against erosion.

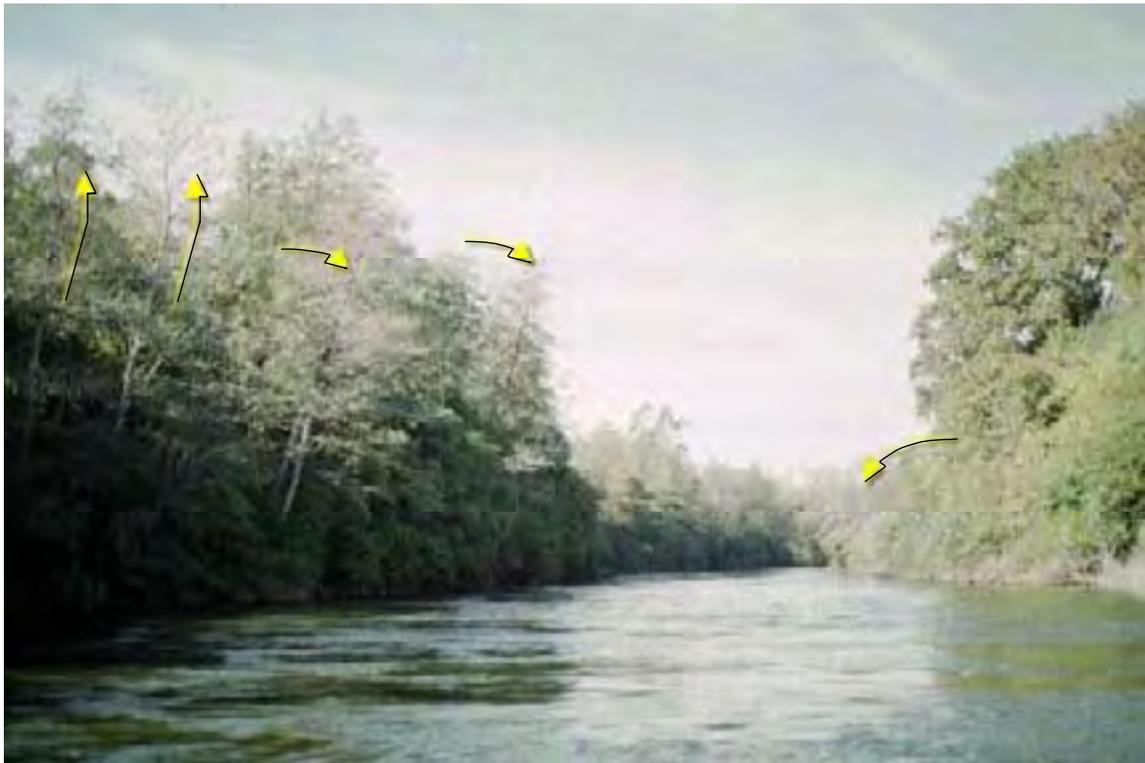
Alongside the oxidation ponds there is a narrow gorge and at the entrance to this gorge the bank is slipping into the channel. Trees leaning into the river (see Fig. 11) show there has been episodic and recent bank failure caused by erosion of the foot of the bank. The bank collapse is evident on both sides of the river indicating that extensive bed degradation has recently occurred in this reach. The position of the angle correction on trees on the left side of Fig. 11 indicates this bank slipped 10 – 15 years ago. The straight leaning trees indicate recent bank movement.

Figure 11 Upstream view near the oxidation ponds showing evidence of recent tree rotation (centre and right arrows) and old rotation (left arrows).

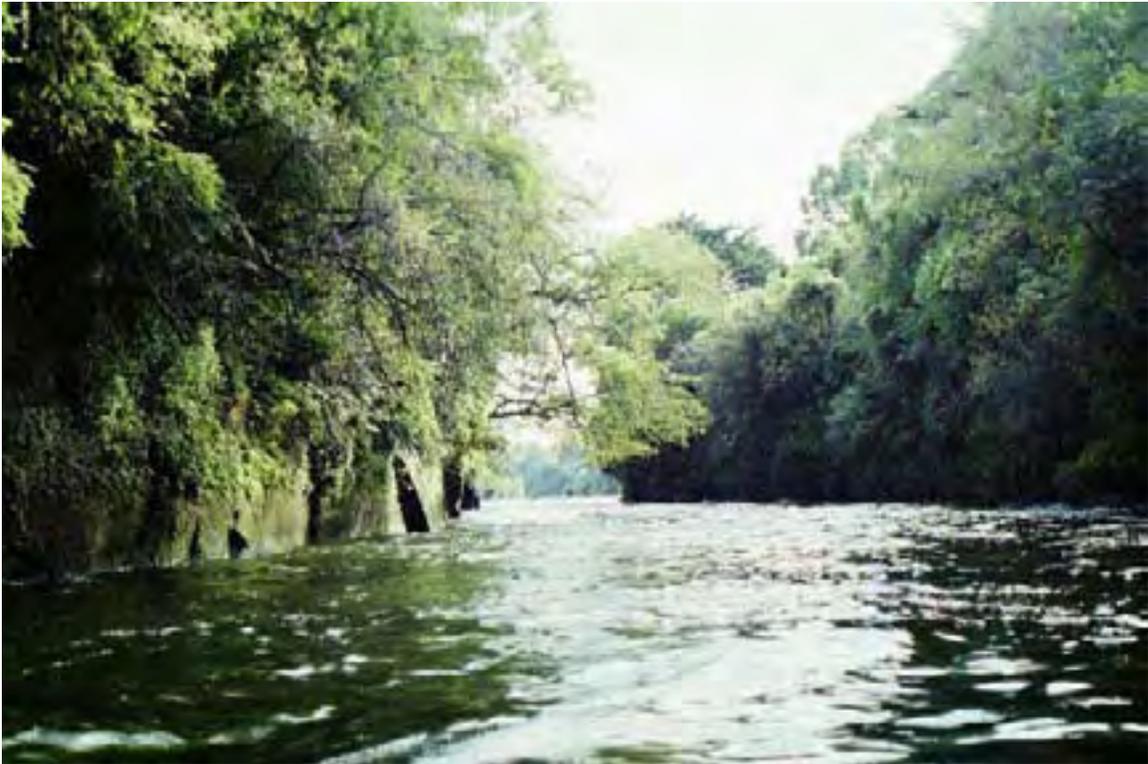
Above this confluence the Waikato becomes very narrow. The reach from 0.6 km to 2 km upstream of the Karapiro Stm confluence is a relatively recent channel that has cut off the previous river channel that flowed behind the golf course. The upstream part of this cutoff is very narrow with vertical walls (Fig. 12). The channel then widens slightly and 2.5 km upstream of Karapiro Stm confluence a small down-cutting tributary enters on the left bank. Upstream of this tributary there are high cliffs on either side of the river and sites of slumping, slips and bank erosion.

Figure 12 View from narrow reach looking downstream towards Cambridge showing bank slippage and falling trees.
