The Potential for Debris Flows from Karaka Stream at Thames, Coromandel

Prepared by:
M.J. McSaveney, R.D. Beetham,
Institute of Geological and Nuclear Sciences Limited
(GNS Science)

For:
Environment Waikato
PO Box 4010
HAMILTON EAST

**GNS Science Consultancy Report 2006/014
February 2006**

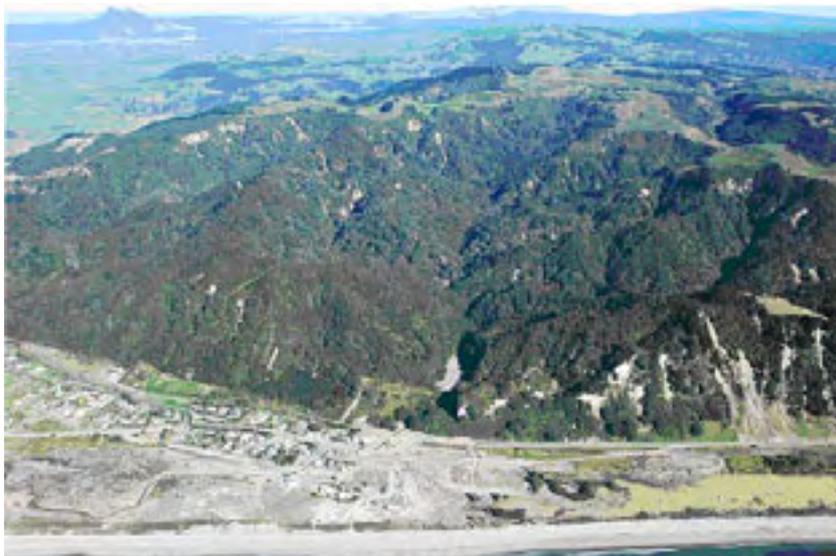
Figure 1.3.1 At Matata, the evidence for past huge debris flows is easy to read in the landscape because a very recent “translation” has been provided. Recognition of this evidence before 2005 could have allowed opportunity to avoid damage though mitigation works and appropriate building restriction where necessary.

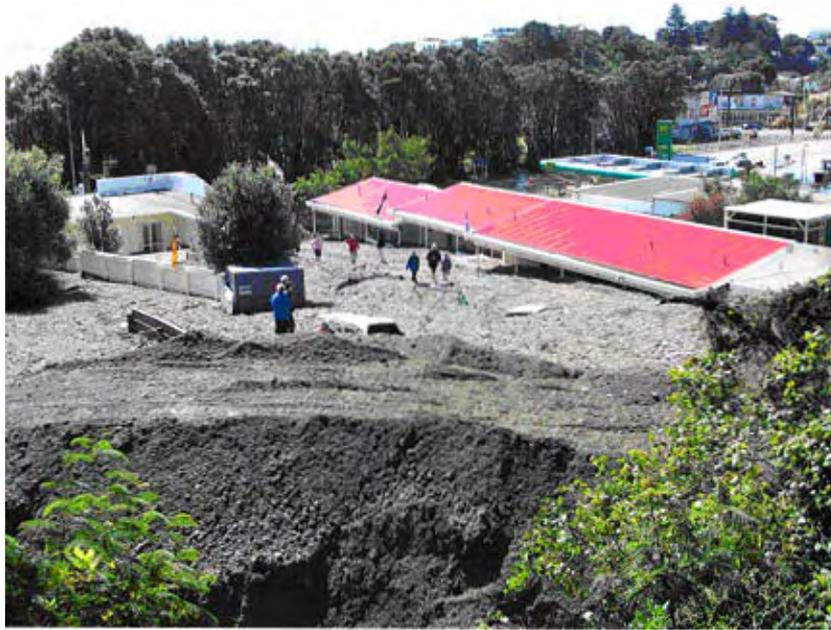
Figure 1.3.2 Debris-flood gravel from the gully exit near Paekakariki Hill Road, north of Wellington, as a result of a storm of 3 October 2003 burying the Belvedere Motel and cars (Hancox G T, 2005).

- A debris flood is a very rapid (up to ~5 m/s), surging flow of water, heavily charged with debris, in a steep channel. Damaging debris floods occurred recently at Paekakariki, north of Wellington during intense rain storms in October 2003 (Figure 1.3.2), in February 2004 and in January 2005^{vi}. Debris floods have occurred at Thames as the downstream consequences of debris avalanches and debris flows in catchments east of the town.

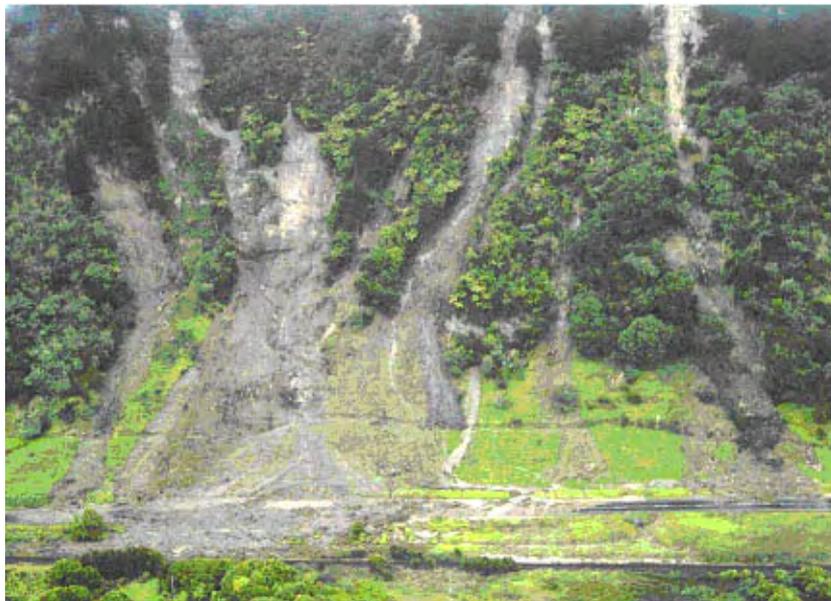
Figure 1.3.3 Debris avalanches near Matata. Debris avalanches such as these initiate debris flows when they fall into stream channels.

- A debris avalanche (Figure 1.3.3) is a very rapid, to extremely rapid (5–20 m/s, 15–60 km/hr), shallow flow of partially or fully water-saturated debris on a steep slope, without confinement in an established channel. Debris avalanches are a very common form of storm-triggered landslide and have occurred widely through the Coromandel and Kaimai Ranges in recent major storms such as those of 1981, 1985, and the Weather Bomb of 2002.

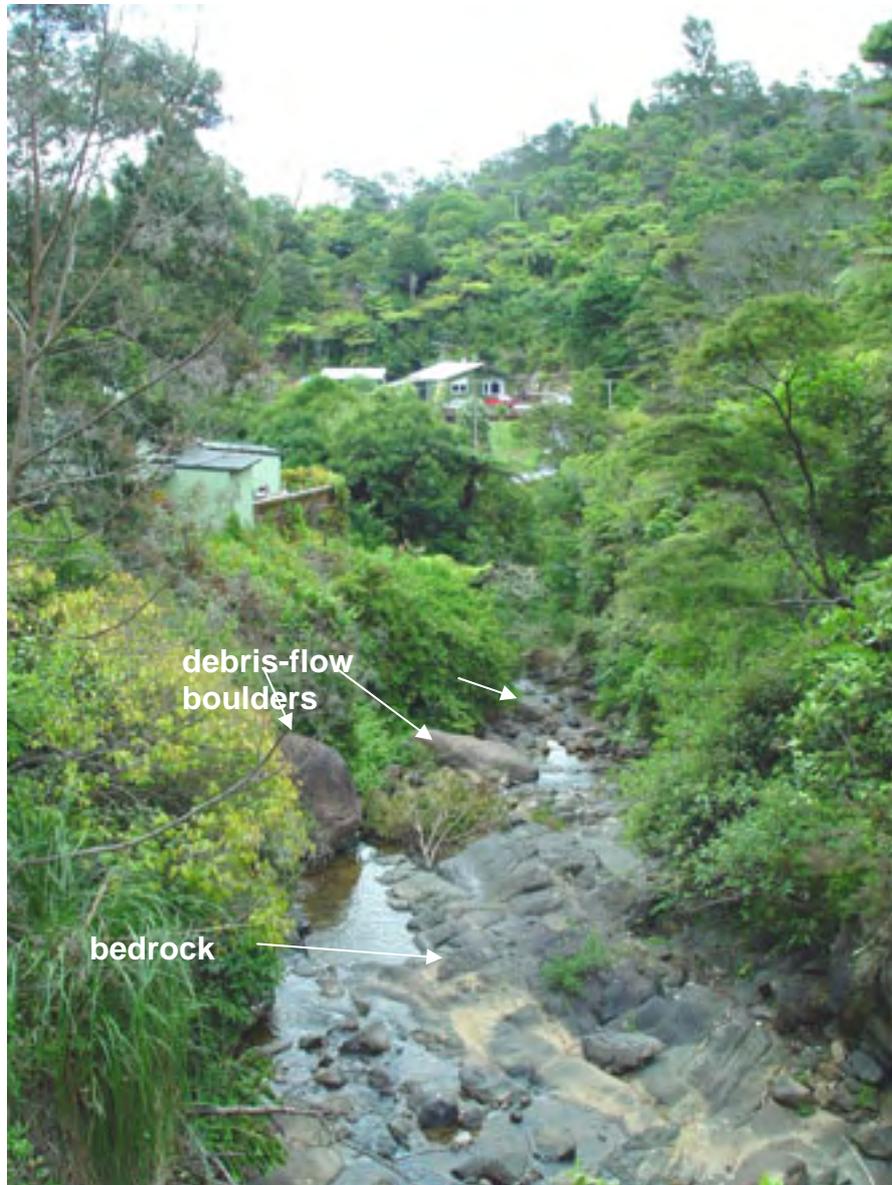
Figure 1.3.5 Debris flows are known for their ability to transport huge boulders as part of their mix of water, sand, gravel, cobbles and boulders. Many large, dense boulders are available in the bed of Karaka Stream. They only move significant distances during rare debris flows. The homes are on a terrace that is the top of the Karaka Stream debris-flow fan.

debris is a mix of silt, sand, gravel, cobbles and boulders (Figure 1.3.5), often with a trace of clay, but not necessarily so. Debris also may contain a significant proportion of organic material including logs, stumps, and organic mulch (Figure 1.3.6).

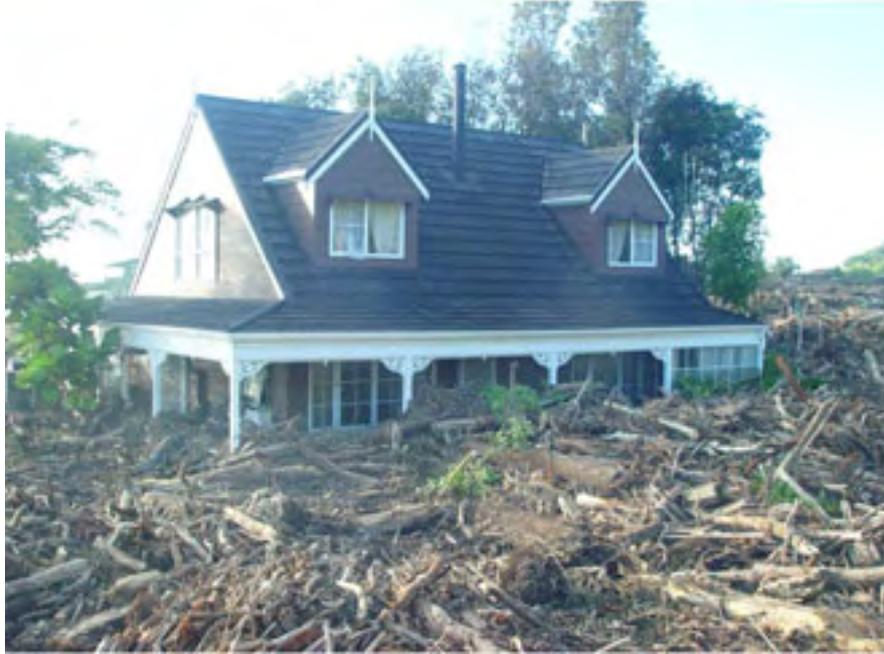
Figure 1.3.6 Organic debris from the catchment forest cover is estimated to have been about 10% of the total debris carried by debris flows at Matata in 2005. As at Karaka Stream, the forest was regrowth after milling, but the condition of the vegetation at Matata played no useful mitigating role in the extreme event which overwhelmed any forest protective capacity. The forest cover at Karaka Stream is well able to mitigate small debris avalanches, but can be overwhelmed in larger events.

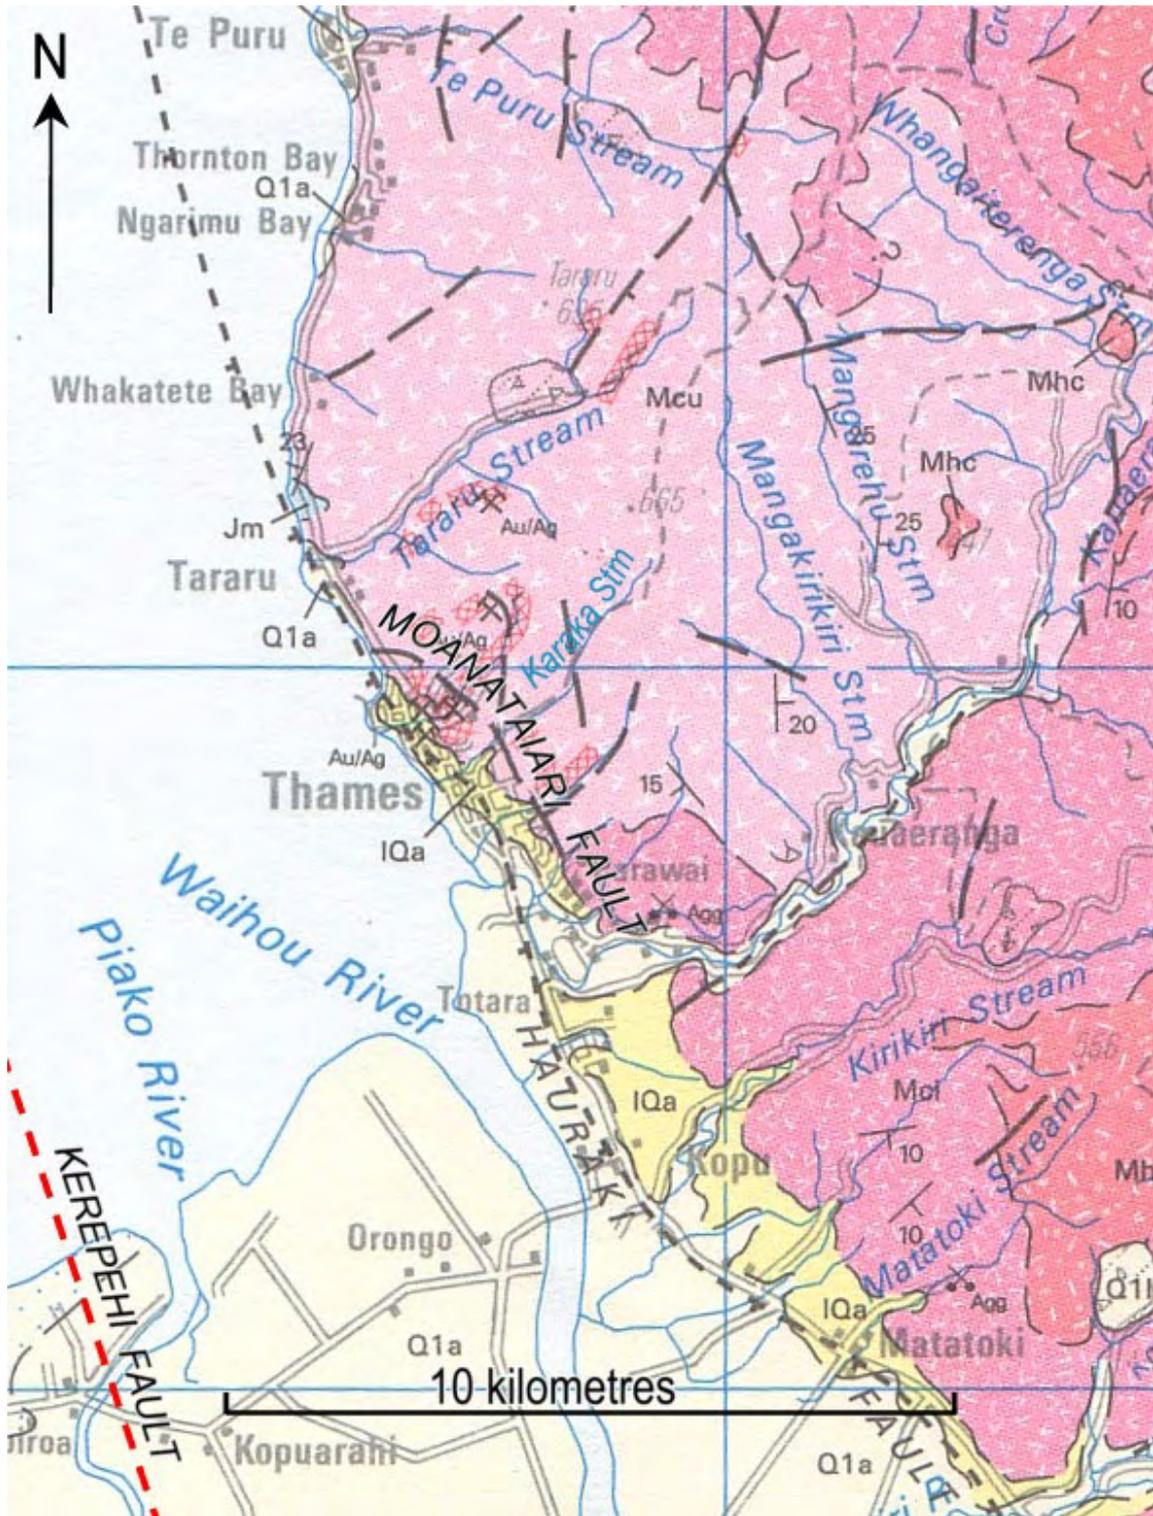
Figure 2.1.1 Geological map of the Thames area showing the distribution of the geological formations discussed in the text, and the major faults recognised in the area. Mcu is Kuaotuna Formation of andesite and dacite flows and tuffs, hydrothermally altered and with gold (Au) and silver (Ag) mineralisation. XXXX is major mineralised quartz vein. Mci is Waiwawa Formation of andesite and dacite flows and tuffs, hydrothermally altered but without gold and silver mineralisation. Mhc is pumice-rich ignimbrite. IQa is late Quaternary fan deposits. Q1a is Swamp/peat deposits. Approximate location of active Kerepehi Fault is inferred by extrapolation of recent trace to South of map area. Data from GNS files.

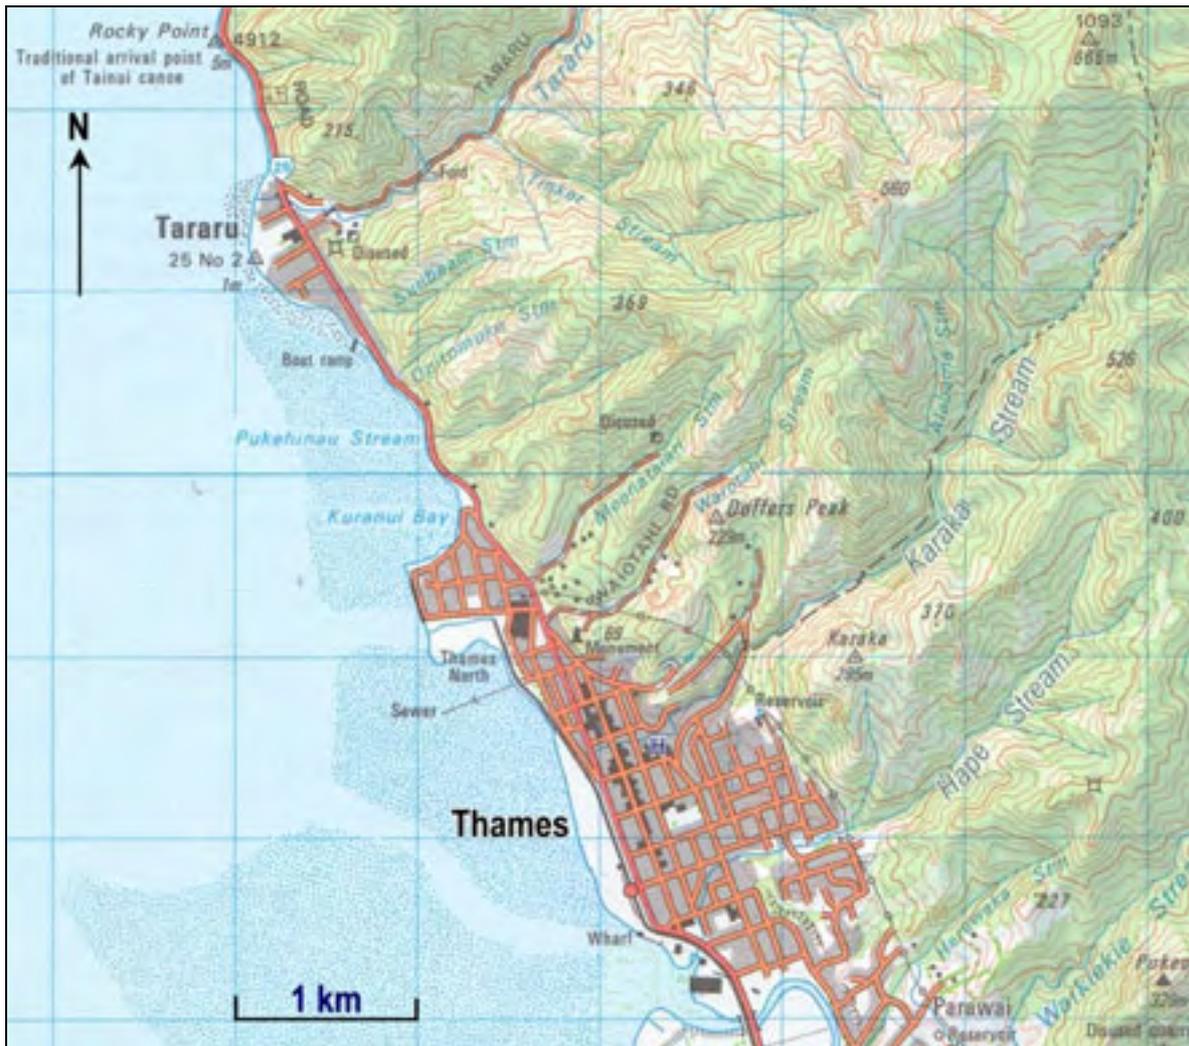
Figure 2.1.2 Topographical map of the Thames area. Section of Topographic map 260-T12 Thames (2001). H is location of Thames Hospital. Grid spacing is 1 km.

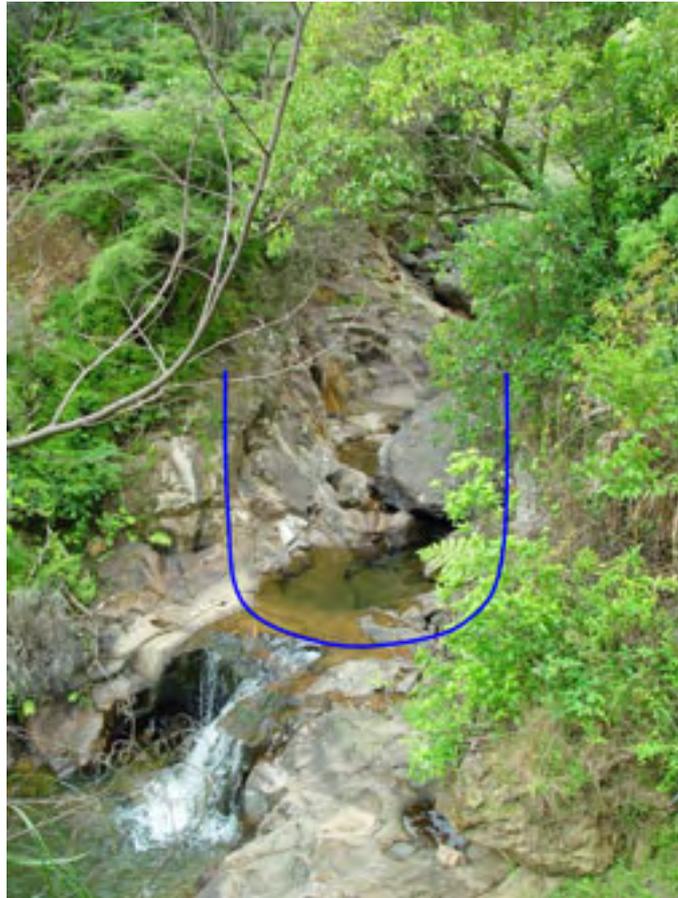
Figure 2.9.1 Debris flows cut a distinctive U-shaped channel that is highly diagnostic of repeated debris flows over a long time.

Debris flows are one of the more powerful agents of erosion. They produce a very distinctive, highly diagnostic, crudely U-shaped channel form – which is widely present in the valleys behind Thames (Figure 2.9.1). Such U-shaped channels in hard bedrock are not formed in a single event, they form over many events. So the presence of a U-shaped channel section in Karaka Stream is convincing proof of many past debris flows.

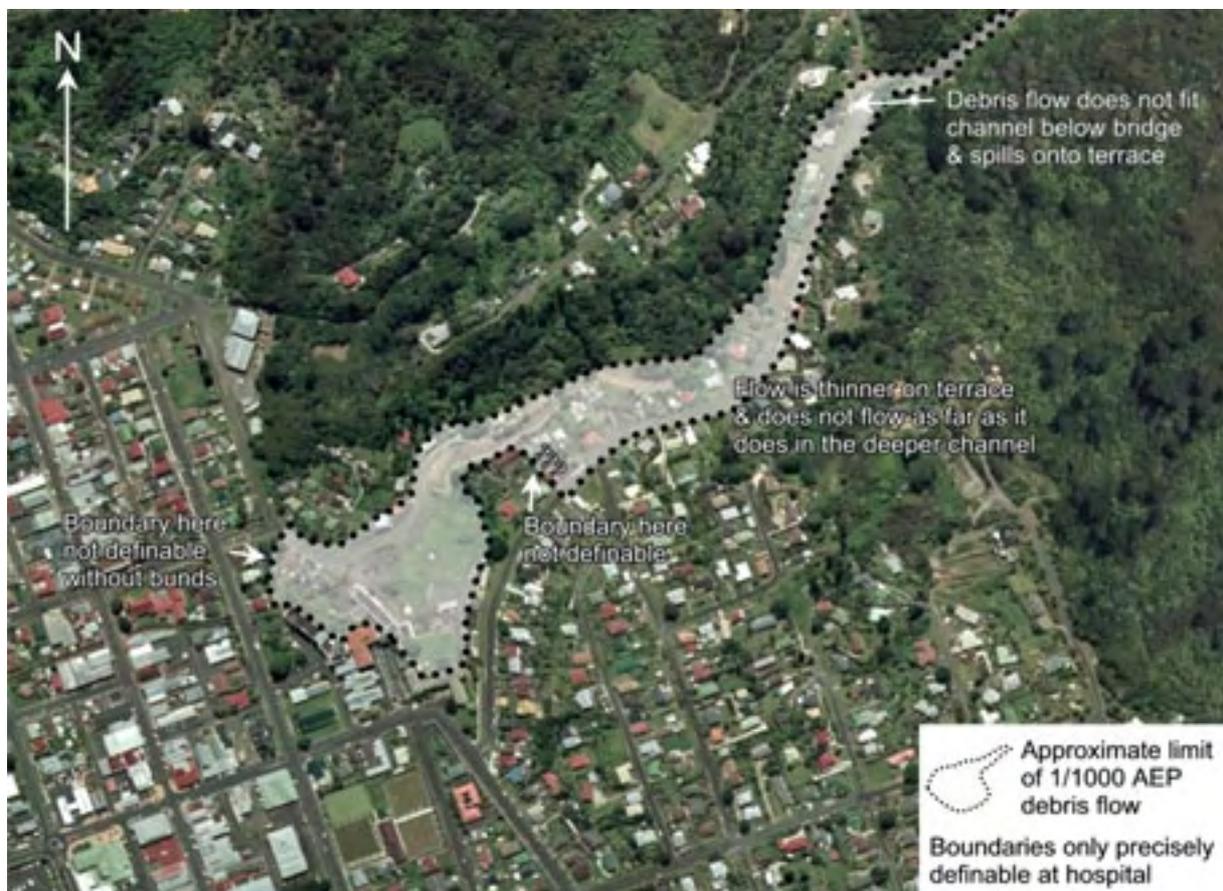
Figure 5.0.1 Aerial photograph of the Karaka Stream fan head showing areas at risk from a debris flow of about 1/1000 annual exceedence probability (AEP). This figure does not show the areas downstream at risk from the consequent debris flood and floodwater inundation. The boundaries are only precisely definable at the hospital, because they are defined by existing substantial buildings. Limits at higher probabilities (debris flows occurring more frequently) lie **at**, or upstream of, the hospital, but are not otherwise definable on existing data. Also, because of the existing large buildings, the limits at lower probabilities, at least to below 1/2500 AEP, remain essentially the same, although the deposits would be deeper because of the greater volumes.

The presence of the hospital complex near the apex of the Karaka Stream fan conveniently limits the area at risk from debris-flow impact to that area upstream of the hospital (Figure 5.0.1), but it does little to limit the areas at risk from flooding. The hospital building complex possibly is the only building complex in Thames of a scale able to withstand debris-flow impact, particularly so because it has an upstream flat area (from the water tanks to the car park) that will reduce the impact velocity of boulders against necessarily strong structures. The hospital's emergency water supply unfortunately is particularly vulnerable to debris flows. Indeed, it probably is vulnerable to anything that overwhelms the existing Karaka Stream flood-mitigating works (which are designed for the 1/60 AEP event).

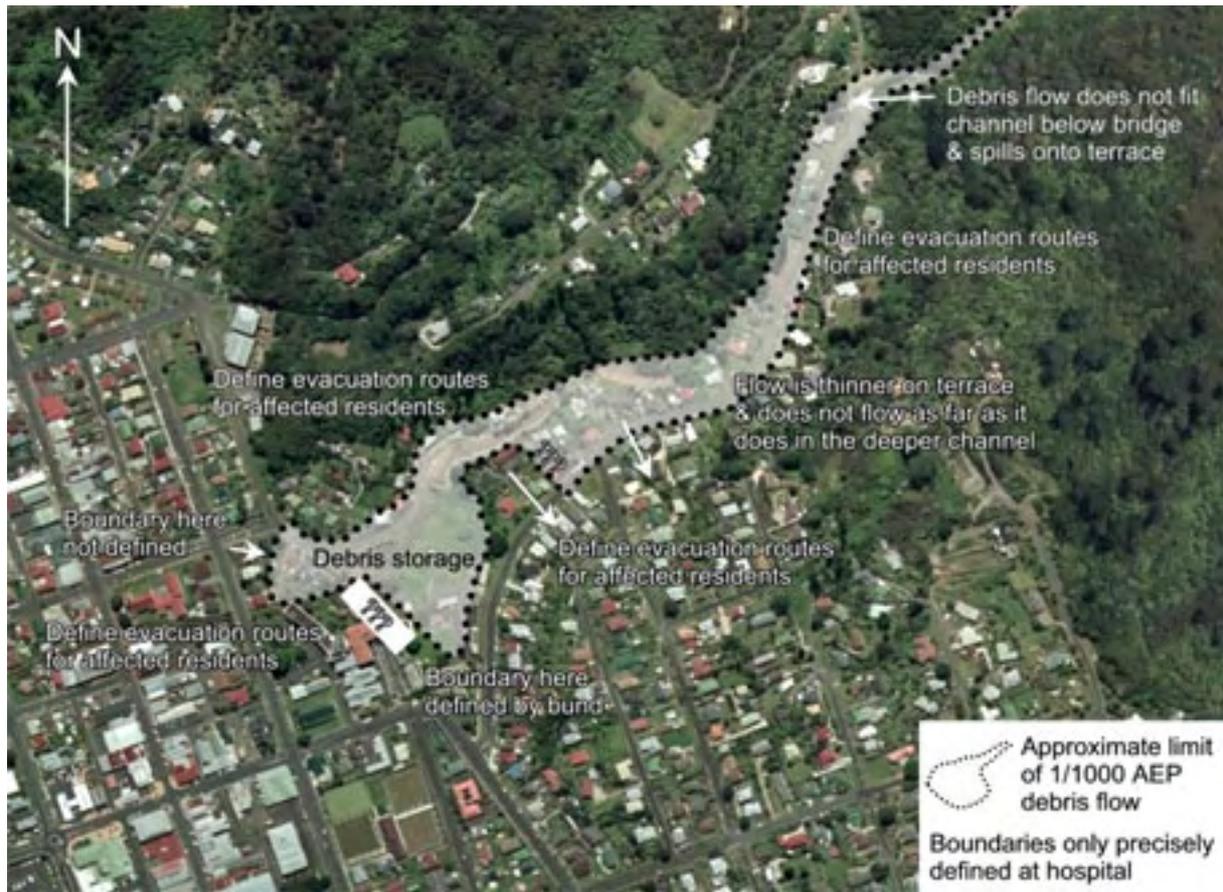
Figure 5.0.2 Aerial photograph of the Karaka Stream fan head showing areas at risk from a debris flow of about 1/1000 annual exceedence probability (AEP) after construction of the proposed new hospital wing. This figure does not show the areas downstream at risk from the consequent debris flood and floodwater inundation. The boundaries are only precisely definable where they might be defined by large bunds (not currently in place) or by valley walls. Limits at higher probabilities (debris flows occurring more frequently) lie at, or upstream of, the hospital, but are not otherwise definable on existing data. Also shown are recommended options for short evacuation routes if residents are warned of an impending debris flow – see section 6.1.

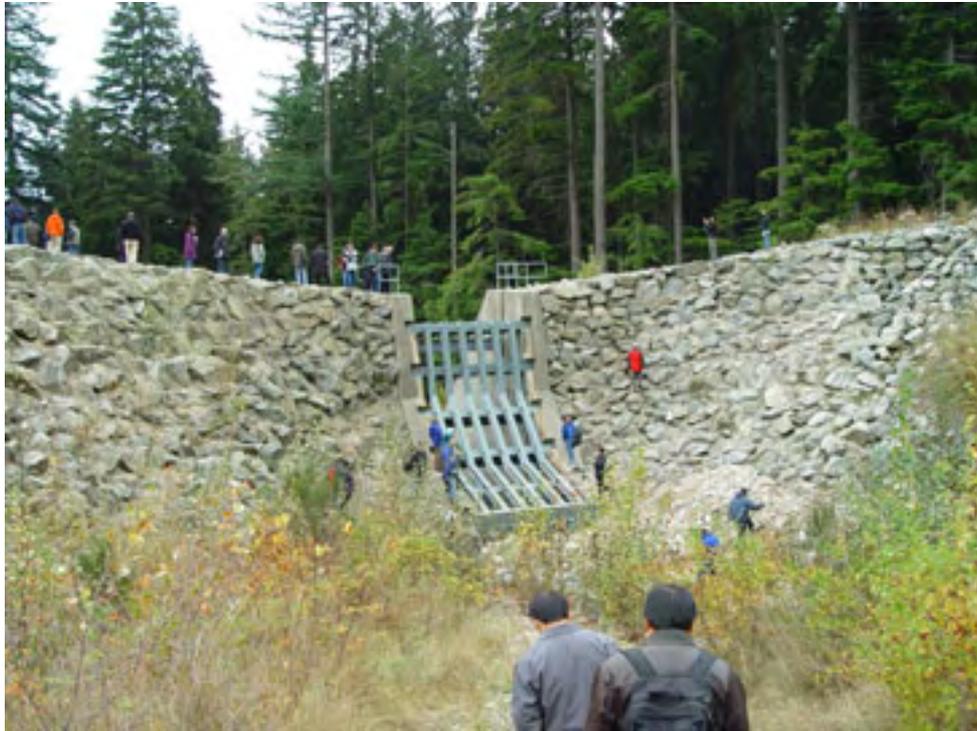
Figure 6.0.1 A debris-retention outflow structure in a sediment-storage basin protecting a northern suburb of Vancouver, Canada. This structure is intended to safely stop events occurring about once in 500 years. To retain this capacity, the basin must be maintained relatively free of debris, and would be cleared after each significant sedimentation event even when these were not debris flows. There is a service road to access the basin for sediment removal.
