Land Process - Peter Reynolds

Why we purchased this new property and the process involved to change it into a prime vegetable production unit.

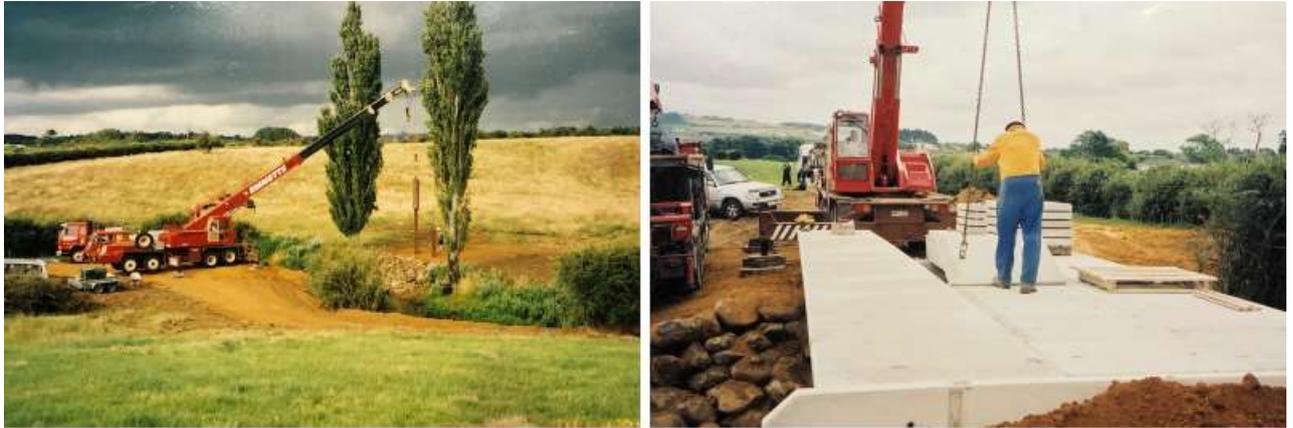
SLIDE 1

The photographs above show the installation of a new concrete bridge to allow access to another 3 hectares across the stream.

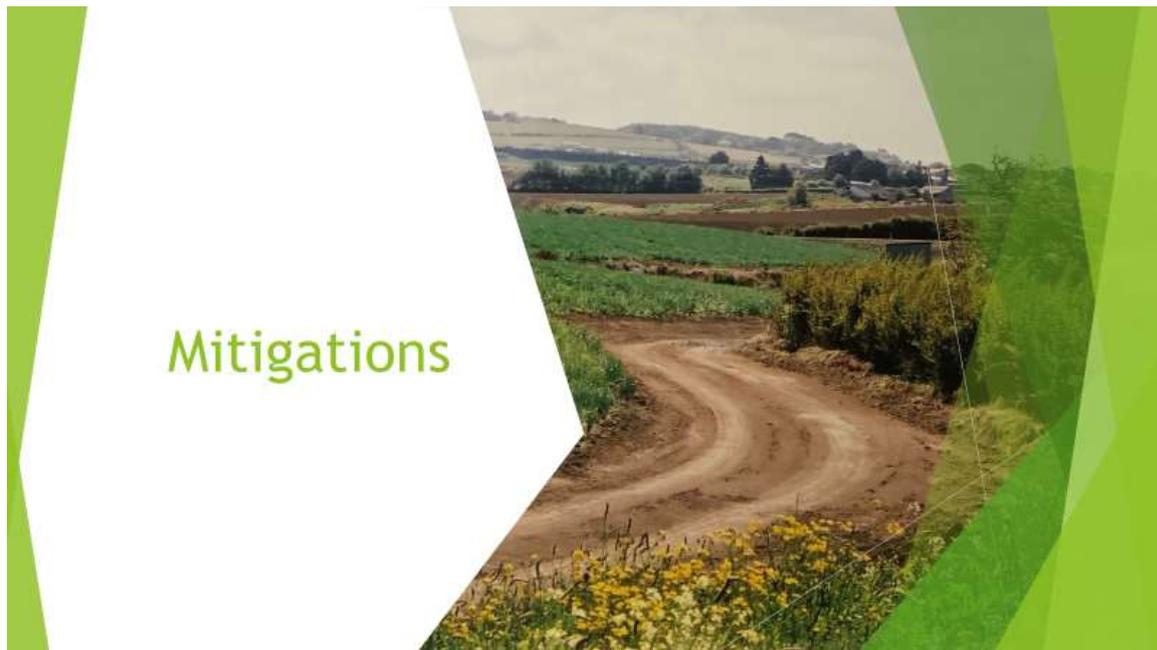
SLIDE 2

We cleared the noxious weeds and rubbish from the stream banks ready for riparian planting of native trees and shrubs.

An important job was to trim some original barberry hedges on the edges of the stream to form the framework of the riparian planting. These barberry hedges are still in use today.

We formed bunded headlands around the stream to stop any soil runoff entering the stream

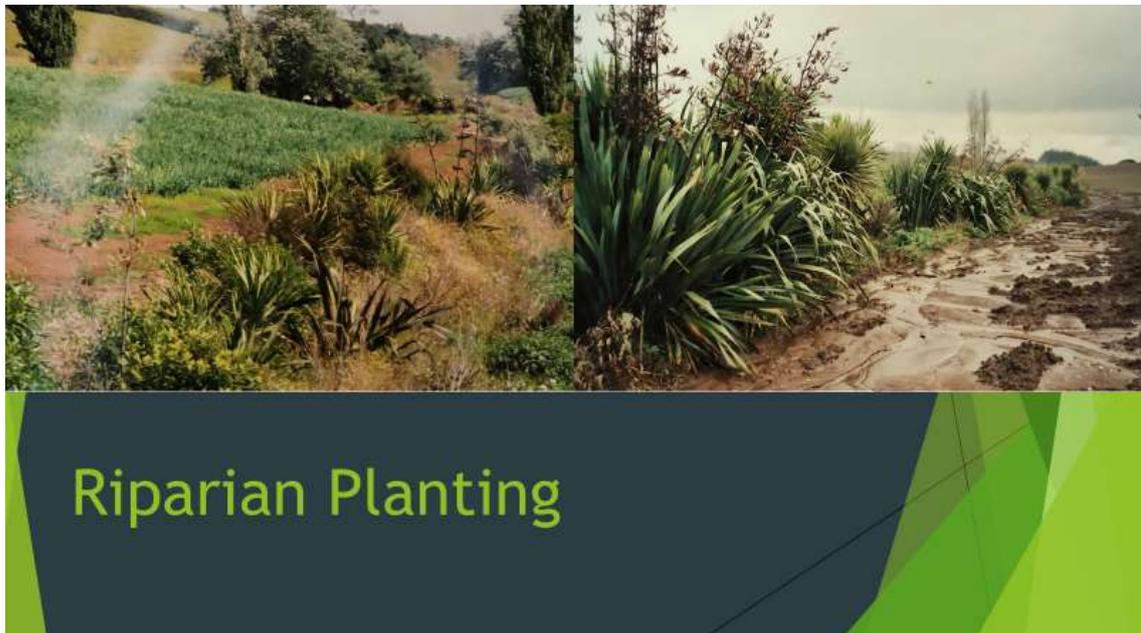
SLIDE 3

In slide 3 the left photo shows the riparian planting becoming established after 2 years.

The right photo shows the riparian planting after 4 years and the silt buildup after a substantial rainfall event in July 2008.

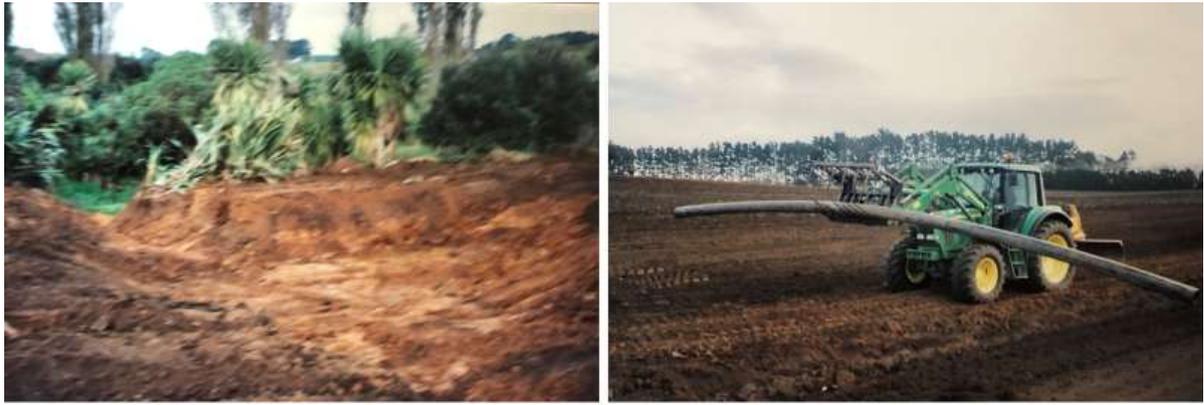
SLIDE 4

Building Silt Traps

Slide 4 shows the construction of another silt trap in 2009.

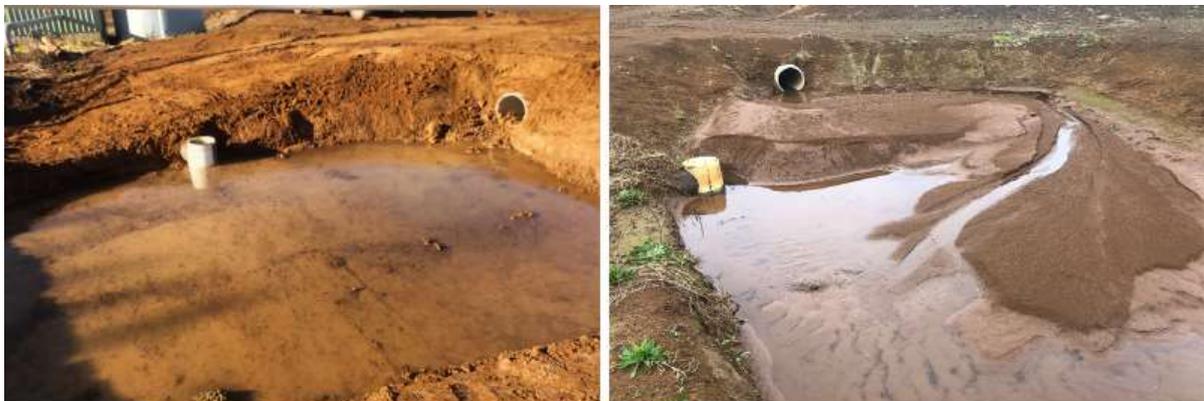
SLIDE 5

Silt Traps in action

Slide 5 shows a silt trap before and after a major rainfall event. It can be seen from the right photo how the soil is dropped out of the flood waters if the silt trap is constructed correctly. The important aspect is to not have the inlet pipe and the outlet pipe aligned.

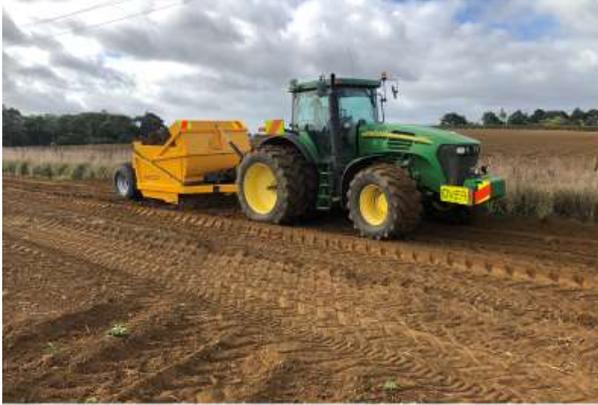
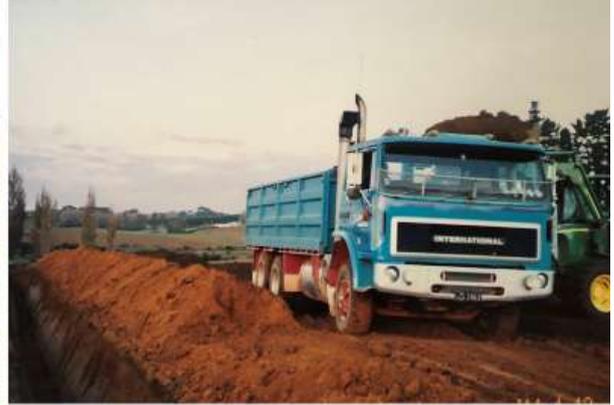
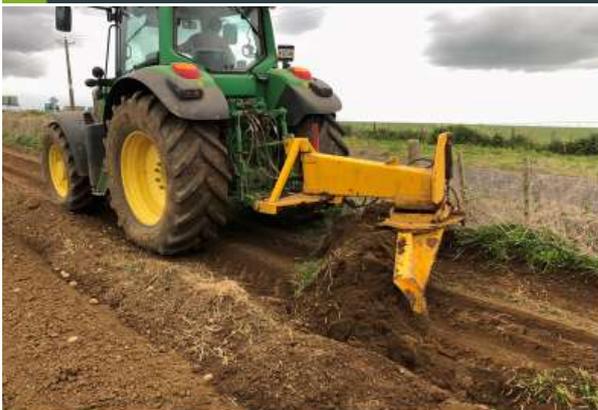
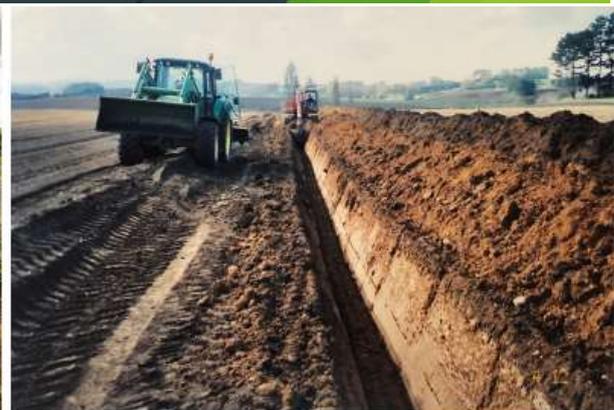
SLIDE 6 & 7

Slide 6 and 7 shows some of the machinery which we use to form the bunded headlands, silt traps and general farm roading and drainage projects.

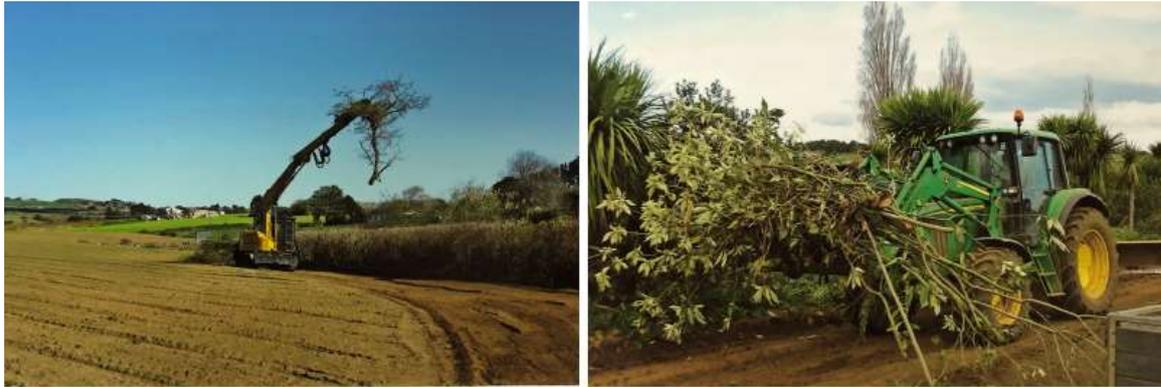
SLIDE 8

Slide 8 shows some of the extreme machinery we have employed to remove noxious weeds which continually invade the riparian plantings.

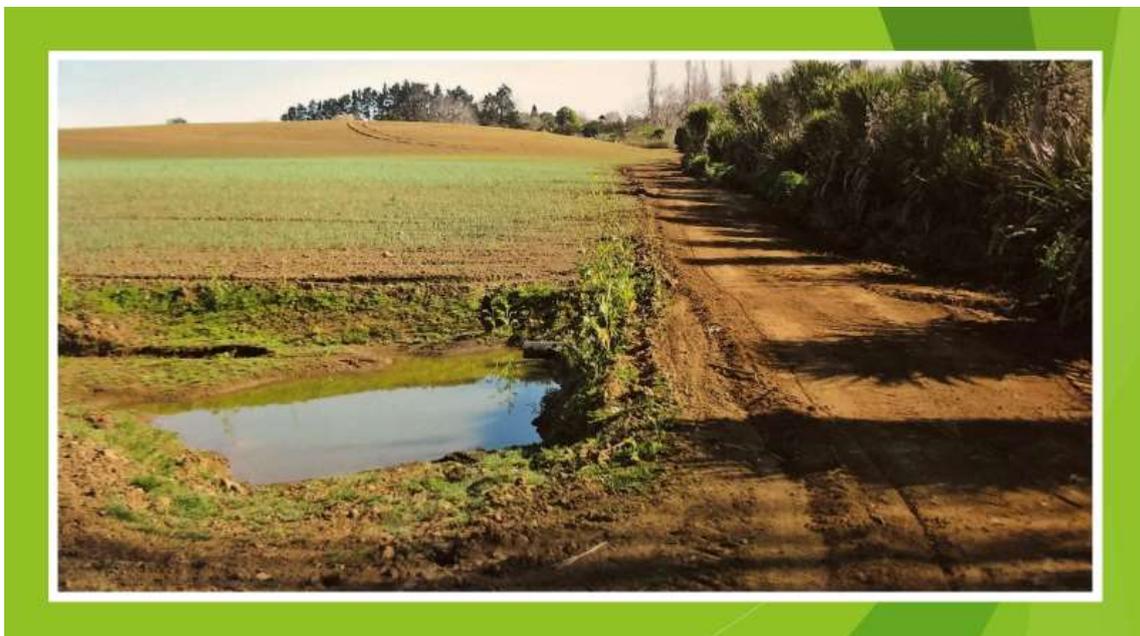
SLIDE 9

It shows a mature planted stream bank, a well constructed silt trap, a well graded bunded headland, a healthy crop of onions and in the distance can be seen a contour drain above a gentle slope.

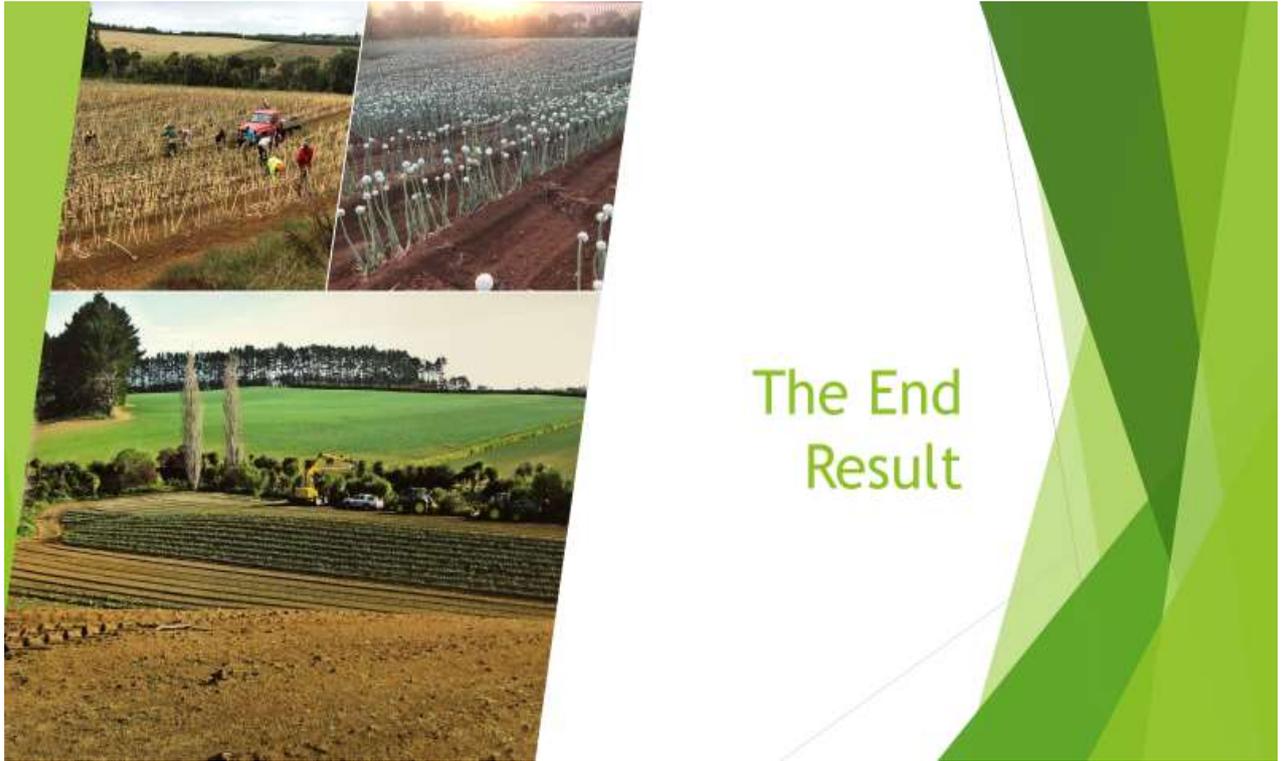
SLIDE 10

Slide 10 shows the great soil type and high value crops. In the distance can be seen the riparian planting and shelter belt which help in producing high quality crops in an environmentally friendly manner.
