# Draft Whangamata Harbour Plan

Looking forward to a healthier harbour

For:  
Environment Waikato  
PO Box 4010  
HAMILTON EAST

June 2007

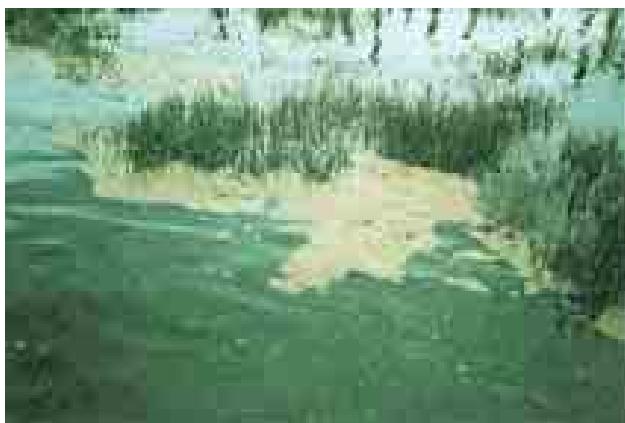
*An example of scum that occurs from time to time in Whangamata Harbour.*

*On 12 December a reconnaissance was made of the Moanaanuanu estuarine mixing zone between the causeway and the golf course. Conspicuous surface features were observed at two locations near the time of high water (colour photographs were taken of these, and copies are available on request). The first was a patch of yellow-brown foam, about 2 m × 1 m in size which was observed in shallow water (c. 0.2 m deep) near the edge of the channel in an area of salt-marsh vegetation (map reference T12, 646 389). It appeared to be typical of the type of foam which is often observed in such areas. I consider it was likely to have been a naturally-occurring estuarine foam, resulting from wind and wave action on polysaccharide surfactants which had been released by coastal plants (e.g. microalgae).*

*These various observations suggest that the foams and scums observed in and near the Moanaanuanu Estuary, while being visually conspicuous—and having the potential to be aesthetically unpleasant, are likely to have been natural phenomena<sup>12</sup>. There was no evidence from these observations that the features were directly associated with sewage.*

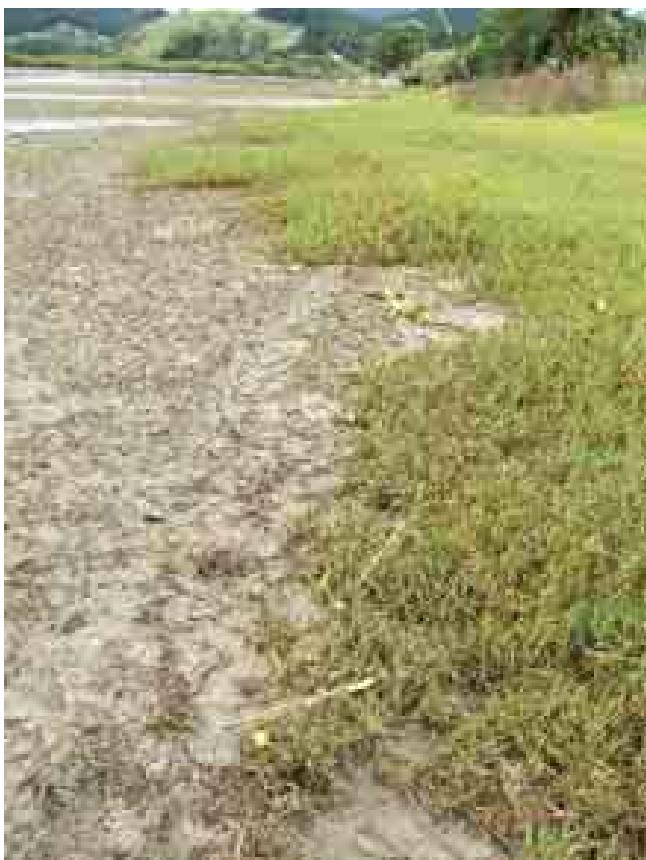
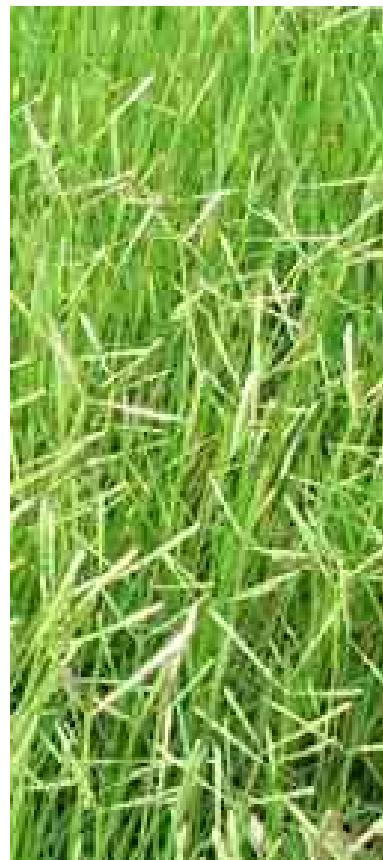
(Left) Saltwater *Paspalum* in the harbour encroaching on seagrass and saltmarsh plants. (Right) Close up of saltwater *Paspalum*.

Weeds such as pampas, kikuyu grass and saltwater *Paspalum* have the potential to smother native vegetation and habitats. These weeds can encroach when sources of native seed are scarce or absent and weeds are not controlled. Weeds are common on the harbour fringe and in some of the drier wetlands.

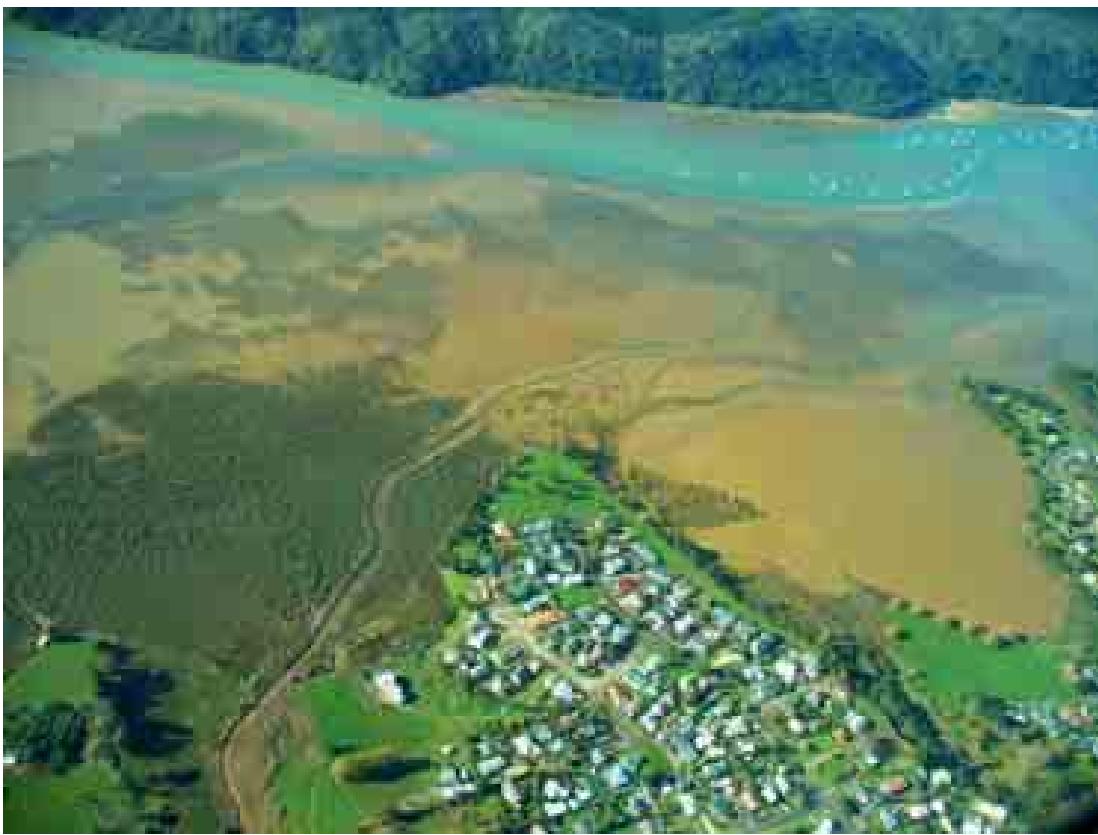
Sediment in Patiki Bay on May 30, 2006.

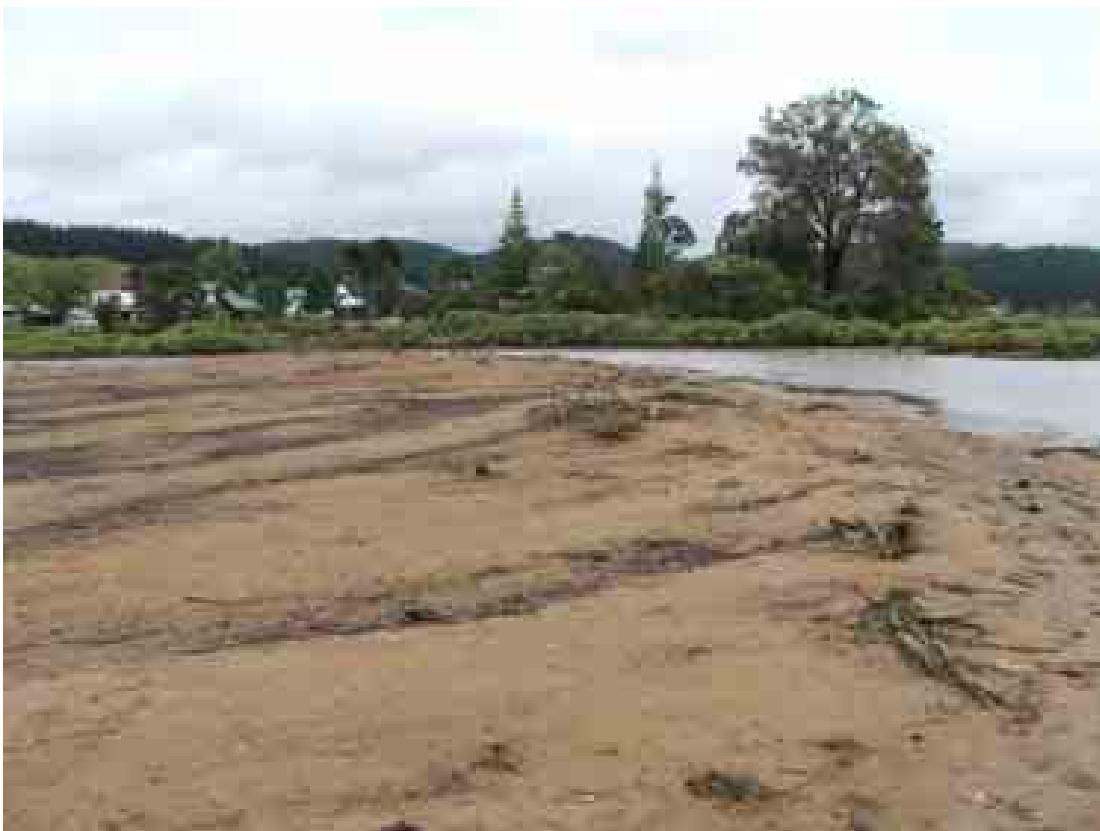
Sediment deposited in Patiki Bay from the Waikiekie stream on January 26, 2006.

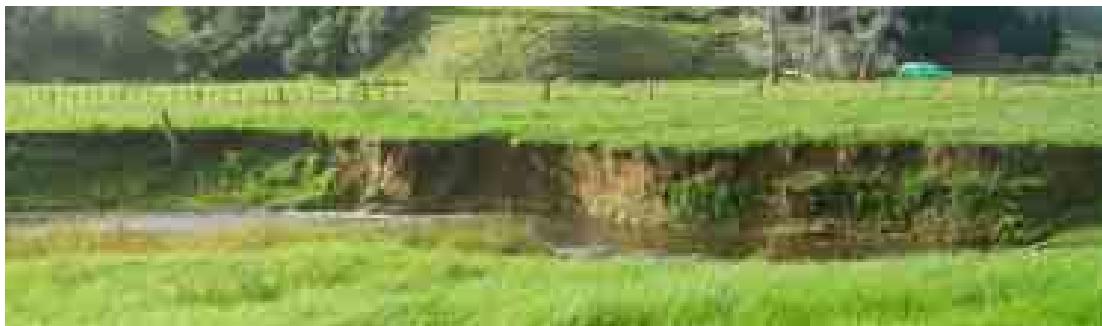
Stream bank erosion on the Wentworth River could be a major contributor of sediment to the Moanaanuanu Estuary – note how deeply cut-in and vertical the banks are.

- Ensure pines are not planted or harvested near streams.
- Explore ways to manage bank erosion along the Wentworth River, including the option of reshaping the banks to prevent continued undermining and collapse into the river.

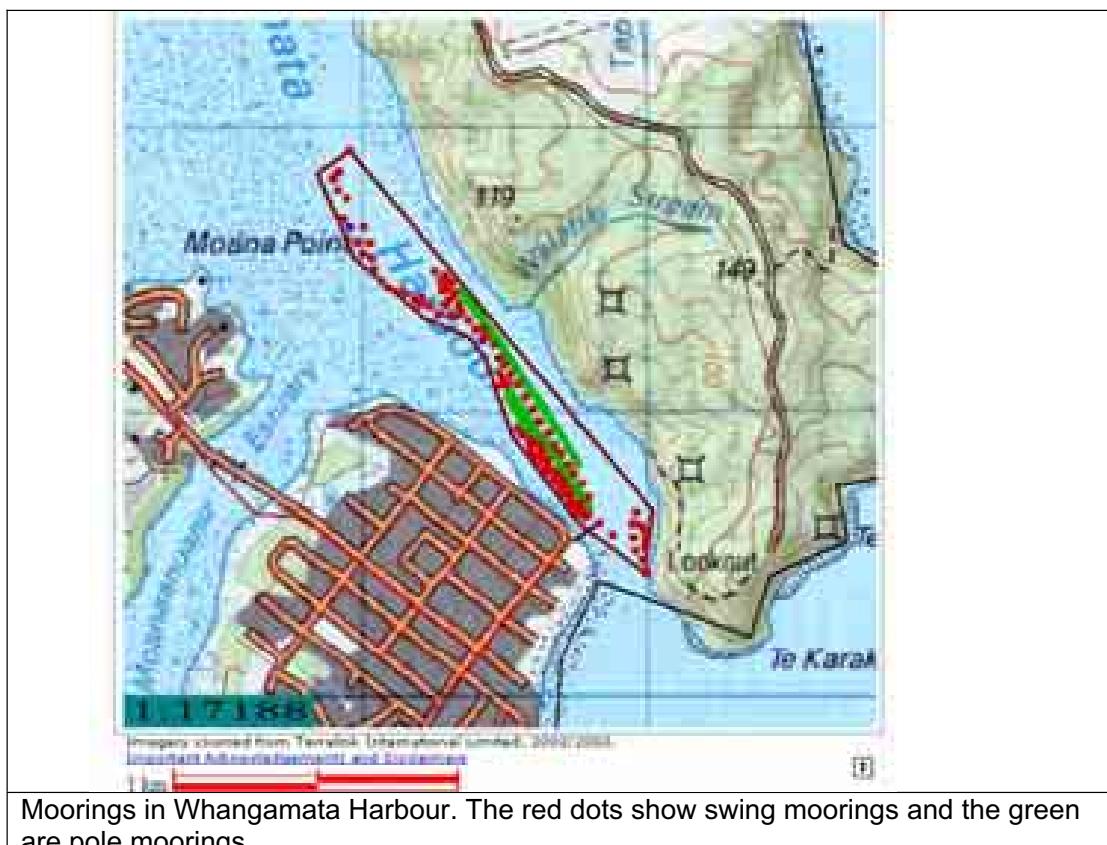
The Regional Coastal Plan specifies a maximum number of 157 moorings within a zoned mooring area. This number is less than the current number of existing moorings. Therefore, no swing moorings can be transferred until such time as the mooring numbers have been reduced to below the maximum number. Currently there are 84 pole moorings and 103 swing moorings. The zoned mooring area and moorings are shown below.
